AugerPrime
Scintillator Surface Detector
OPERATIONS READINESS REVIEW
The Detector

AugerPrime
Scintillator Surface Detector
OPERATIONS READINESS REVIEW
The Status

AugerPrime
Scintillator Surface Detector
OPERATIONS READINESS REVIEW
Maintenance and Spares

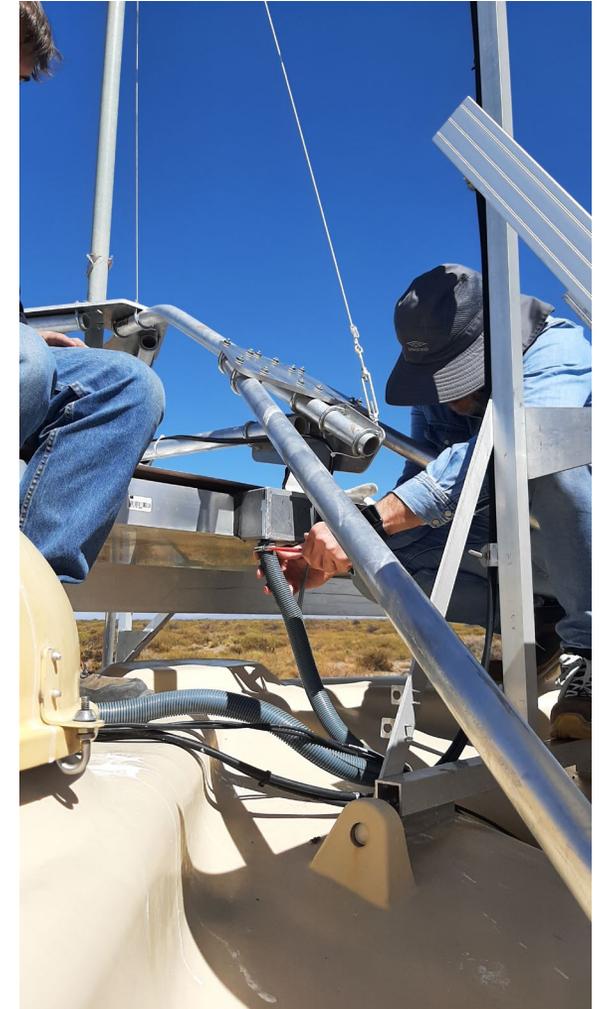
Cable protection problem:

Cable protective jackets

Sewing thread is not UV resistant, so it breaks

A temporary solution: use UV-resistant zip ties to keep the jackets closed

Possible alternatives identified, but not available in Argentina – work in progress

New cable protection installed in few SD

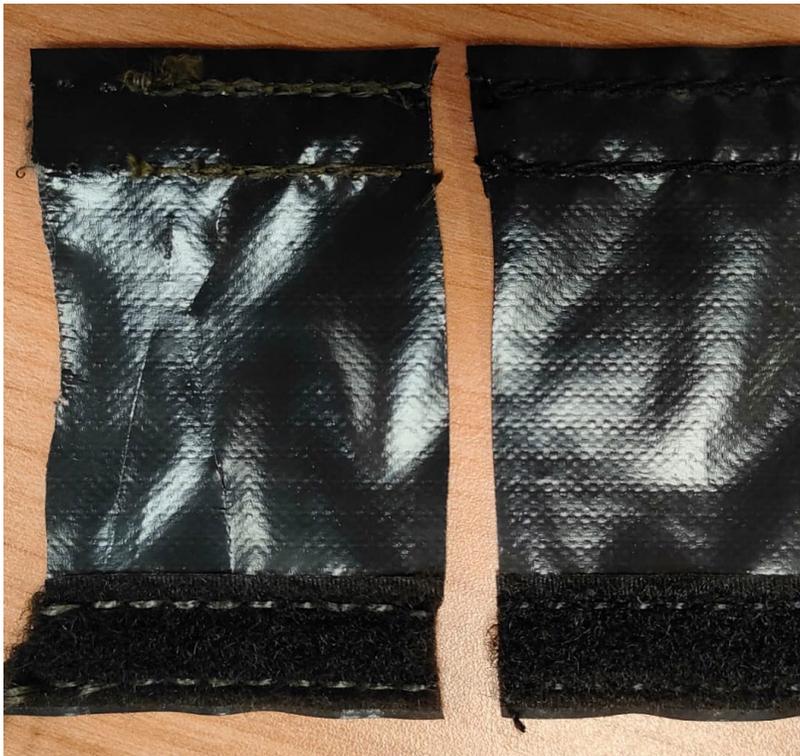
Aging test in specialized laboratory in Lecce.

Reproduced the damage due to combination of temperature change and UV exposure in the lab.

The string is destroyed after an equivalent time of exposure 10.2 months at Malargue with an uncertainty of 20%. This result is well in agreement with the experimental evidence in the field.

The new tube lost its mechanical property in a time 10 times longer.

Tube protections for all the detectors have to be shipped to Malargue.

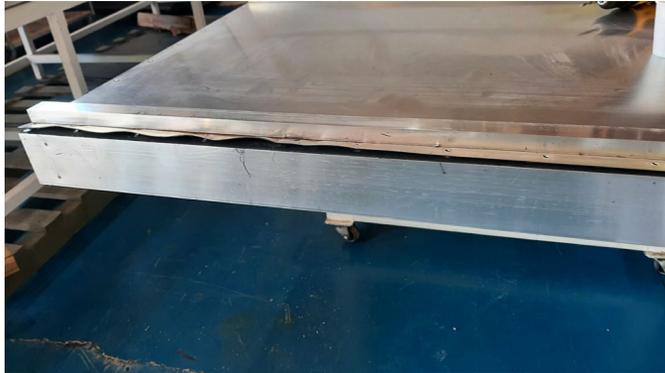
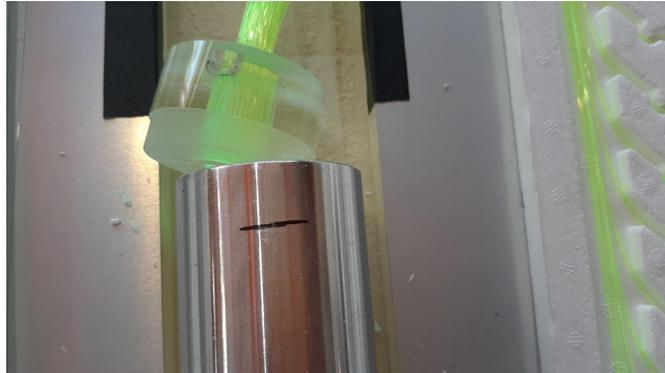
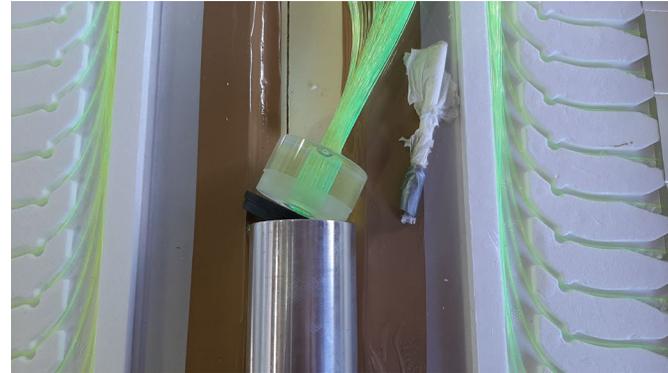
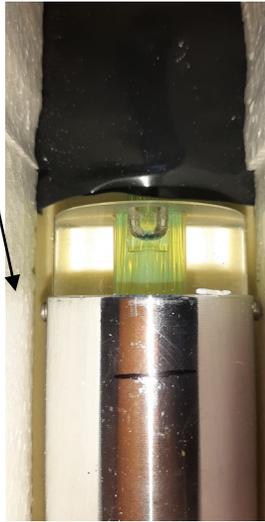
Case 2 and 3 Cookie problem: cookie misplaced.

sealing

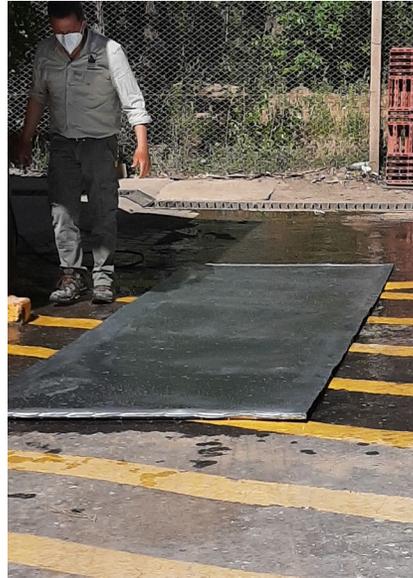
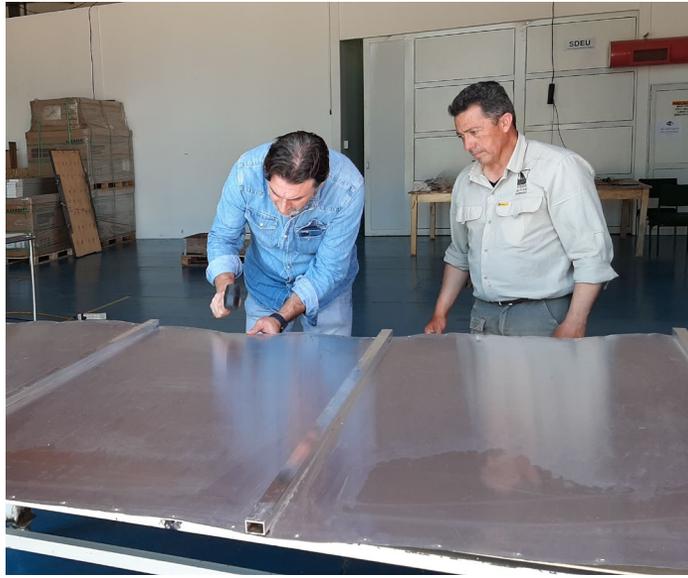
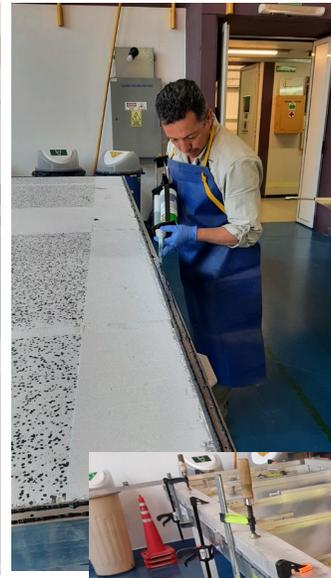
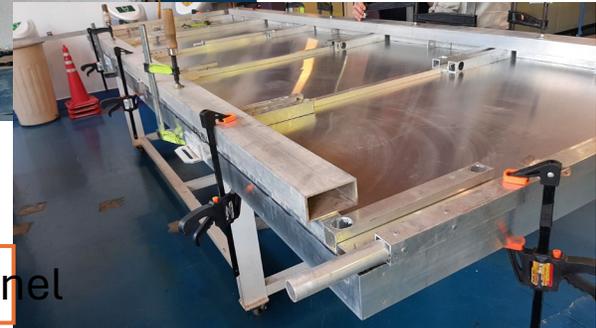
Some difficulties to optimize the curing given the presence of the bars on the upper panel

Cleaning and Flattening the top cover (long and tedious work)

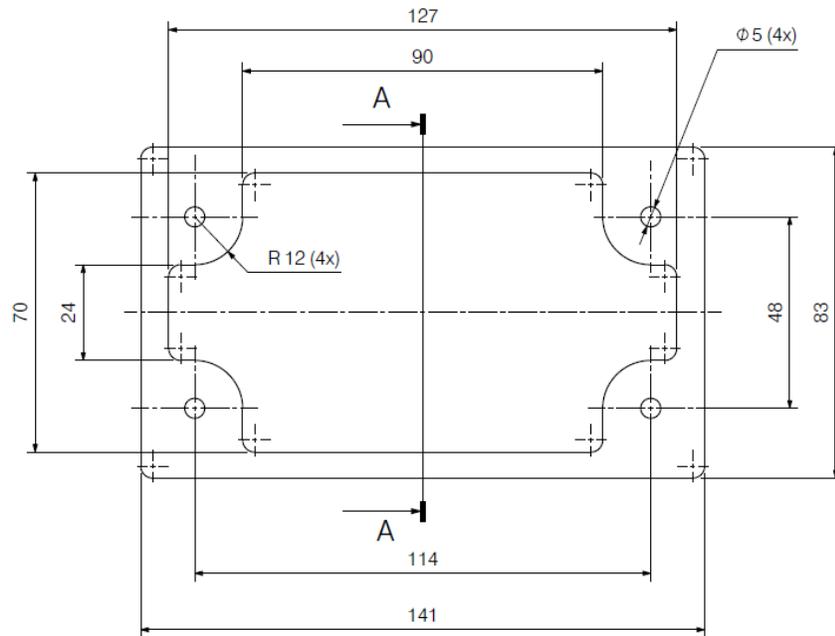
1. The new solution adopted for the cable protection (previous slides)
2. A gasket added between the alu-box and the detector to protect the alu-box from water.

The material used for the gasket is EPDM with hardness 60. Drawing available.

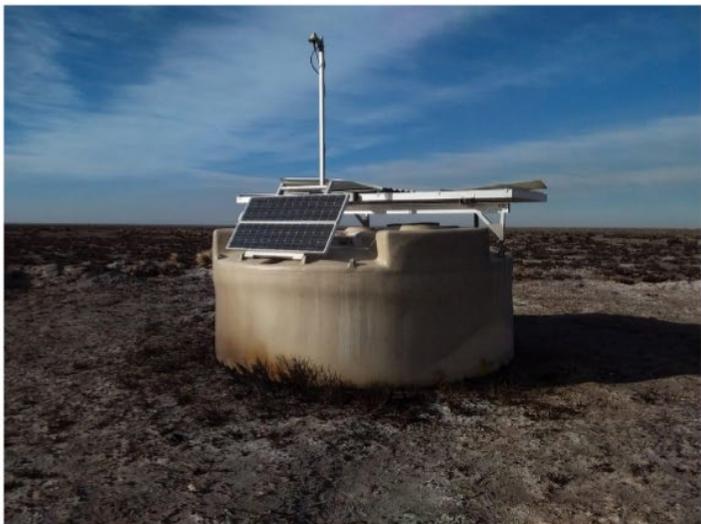
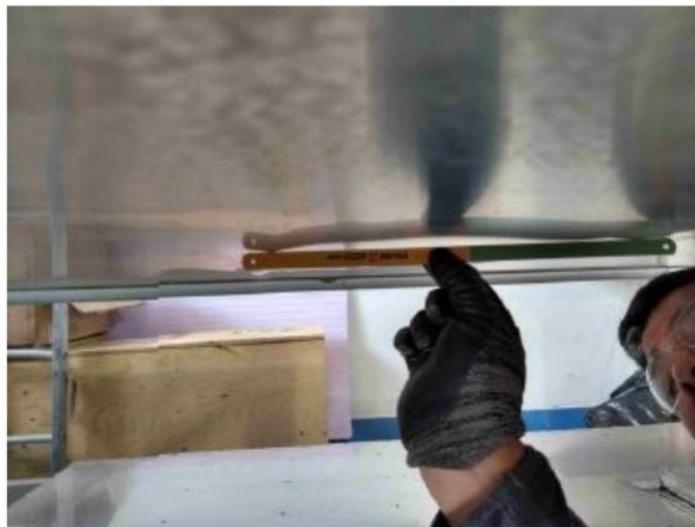
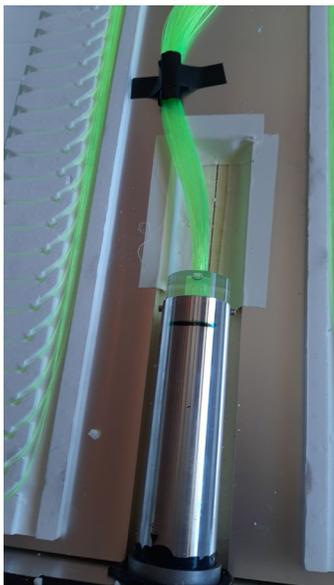
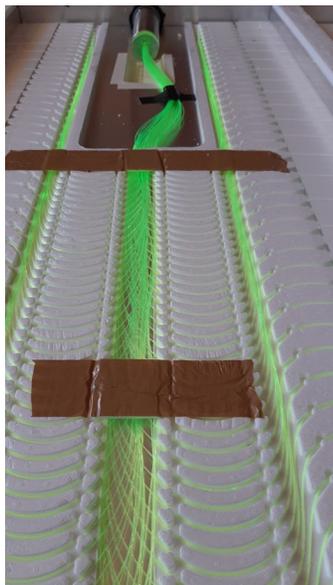
Case I - The detector suffered a fire in the field. The lower panel appears deformed and was in the Assembly Building to check if the interior is damaged.

Inside the detector was intact. Apparently the fire was very intense but short lasting (cortadera) and the bottom panel insulated properly. Although the “integrity” of the interior, the lower panel is certainly compromised and **we did not perform the closing procedure.**

The detector has been converted for OUTREACH

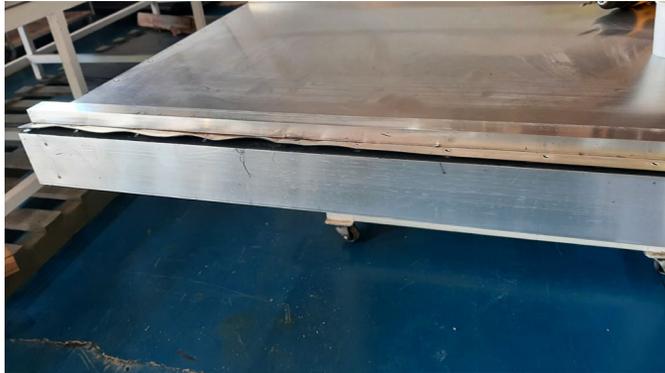
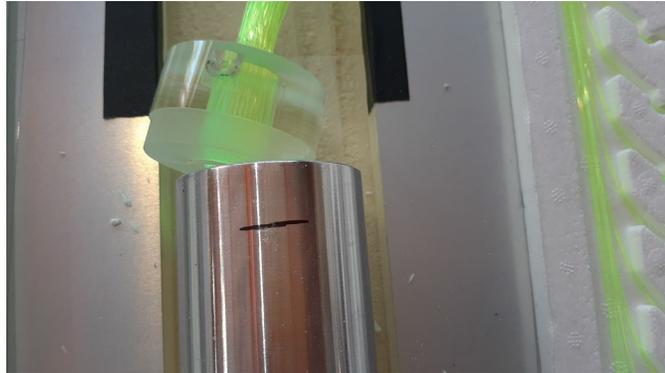
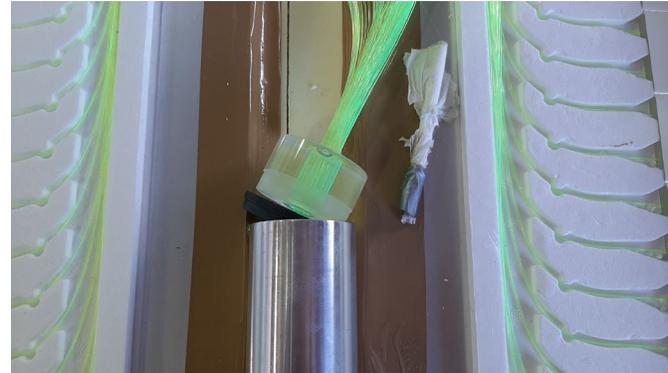
Case 2 and 3 Cookie problem: cookie misplaced.

Simple repair
(placing screws)

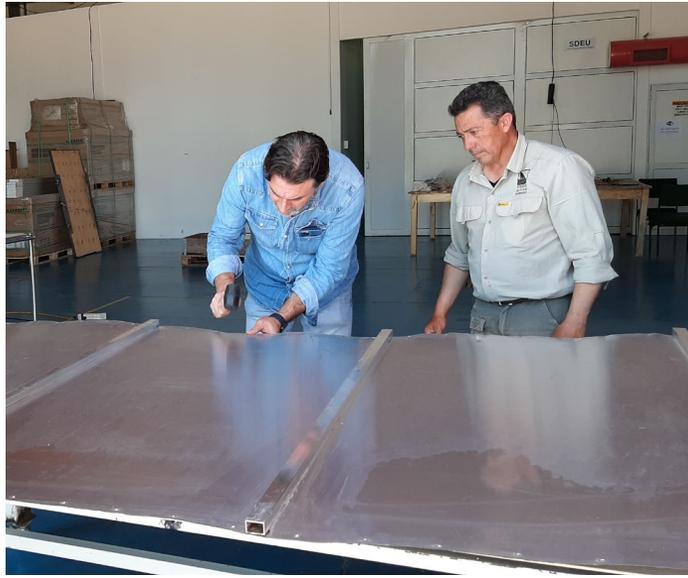
Some difficulties to optimize the curing given the presence of the bars on the upper panel

Cleaning and Flattening the upper panel (long and tedious work)

sealing

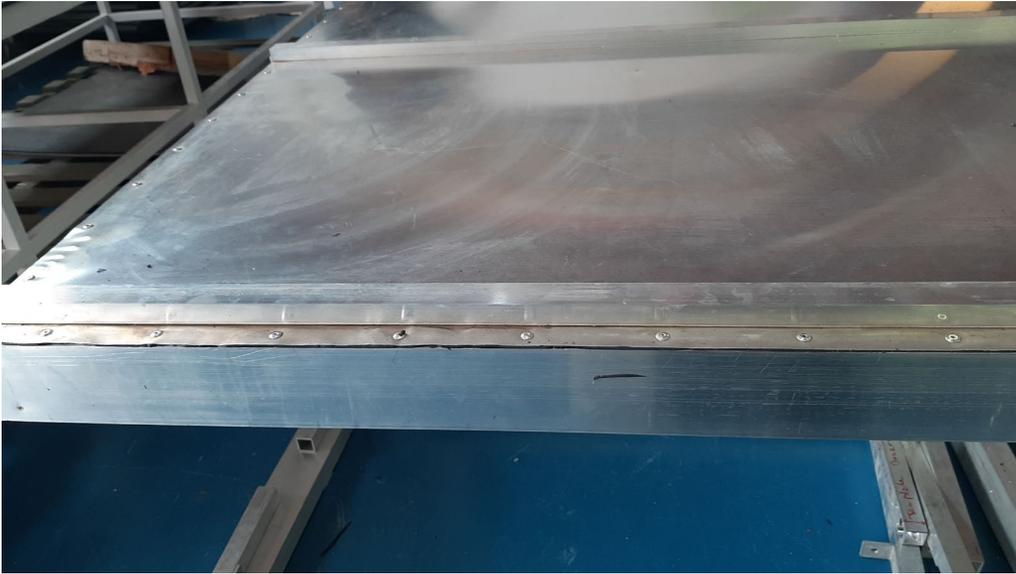
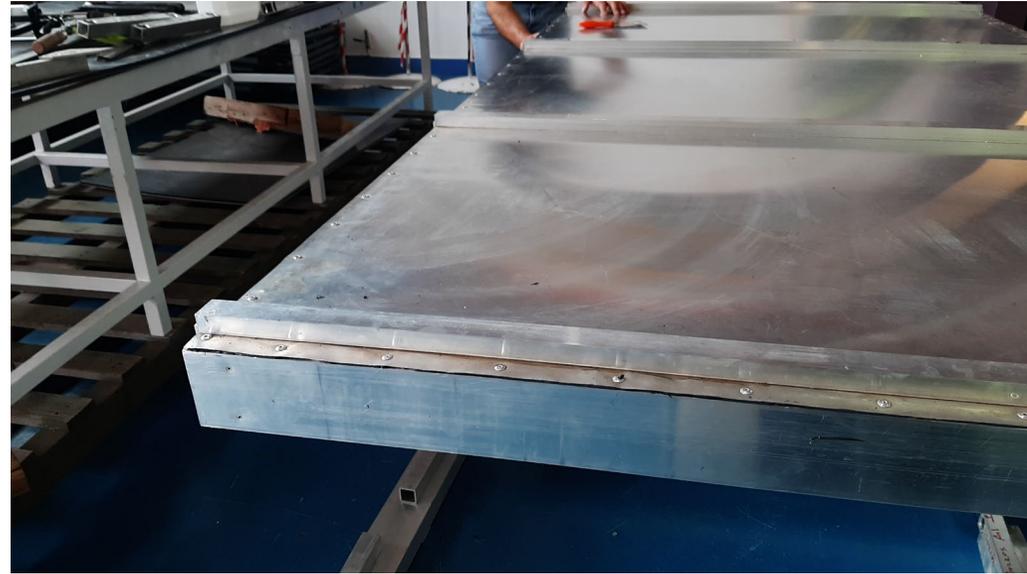
Case 2 and 3 – closed detectors

We checked with PMT/UUB and the signal seems ok.

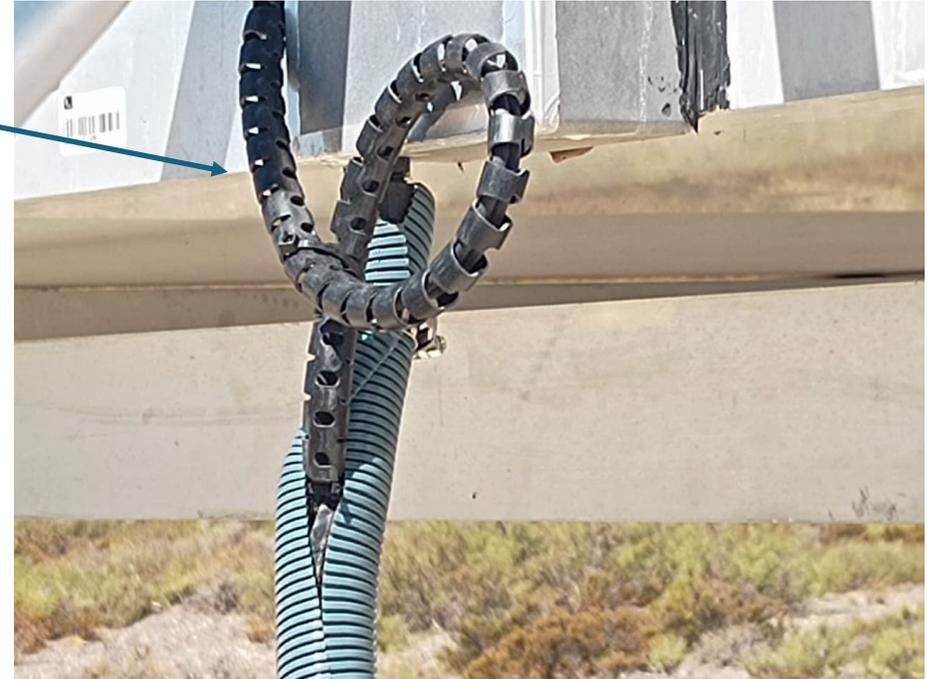
1- Purtroppo il copricavo RD non è sufficiente a contenere entrambi i cavi, inoltre l'ingresso del cavo RD nell'housing del cavo SSD costituisce già ora un punto potenzialmente delicato in quanto può convogliare acqua nella zona «BOX elettronica»
