Radio Detector

Operations Readiness Report

AugerPrime Radio detector operation readiness review

RD LNA failure analysis

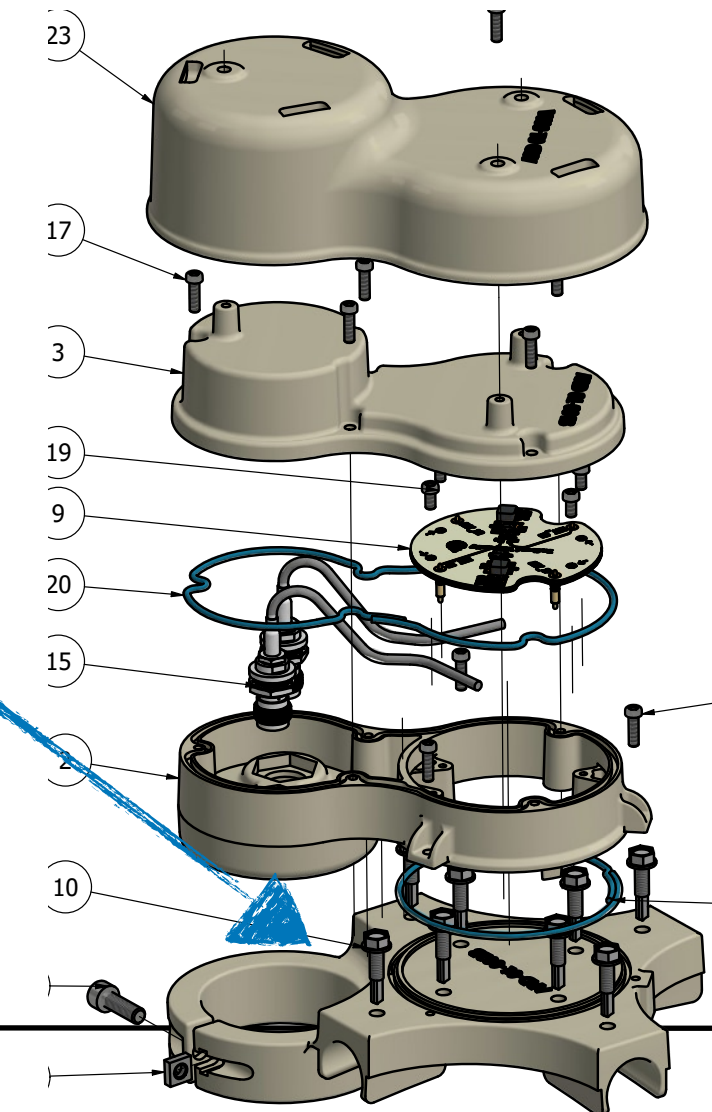
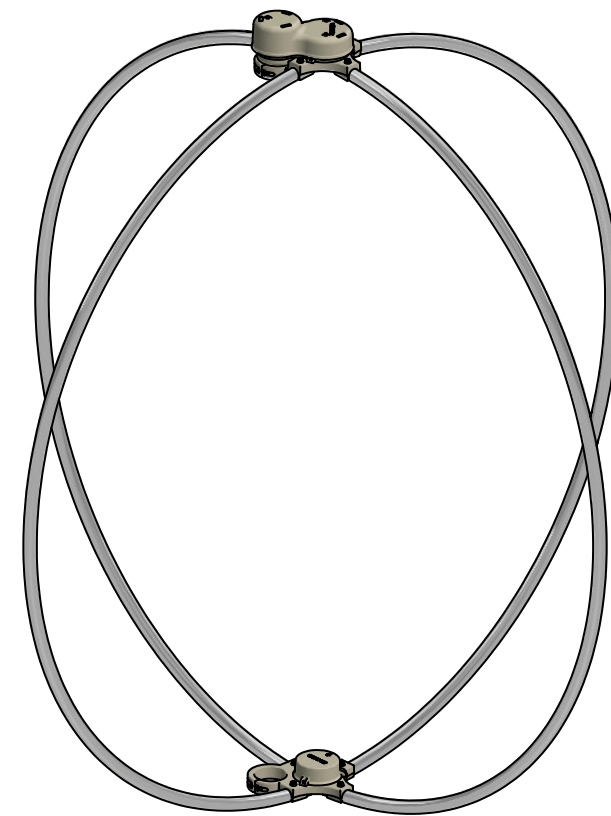
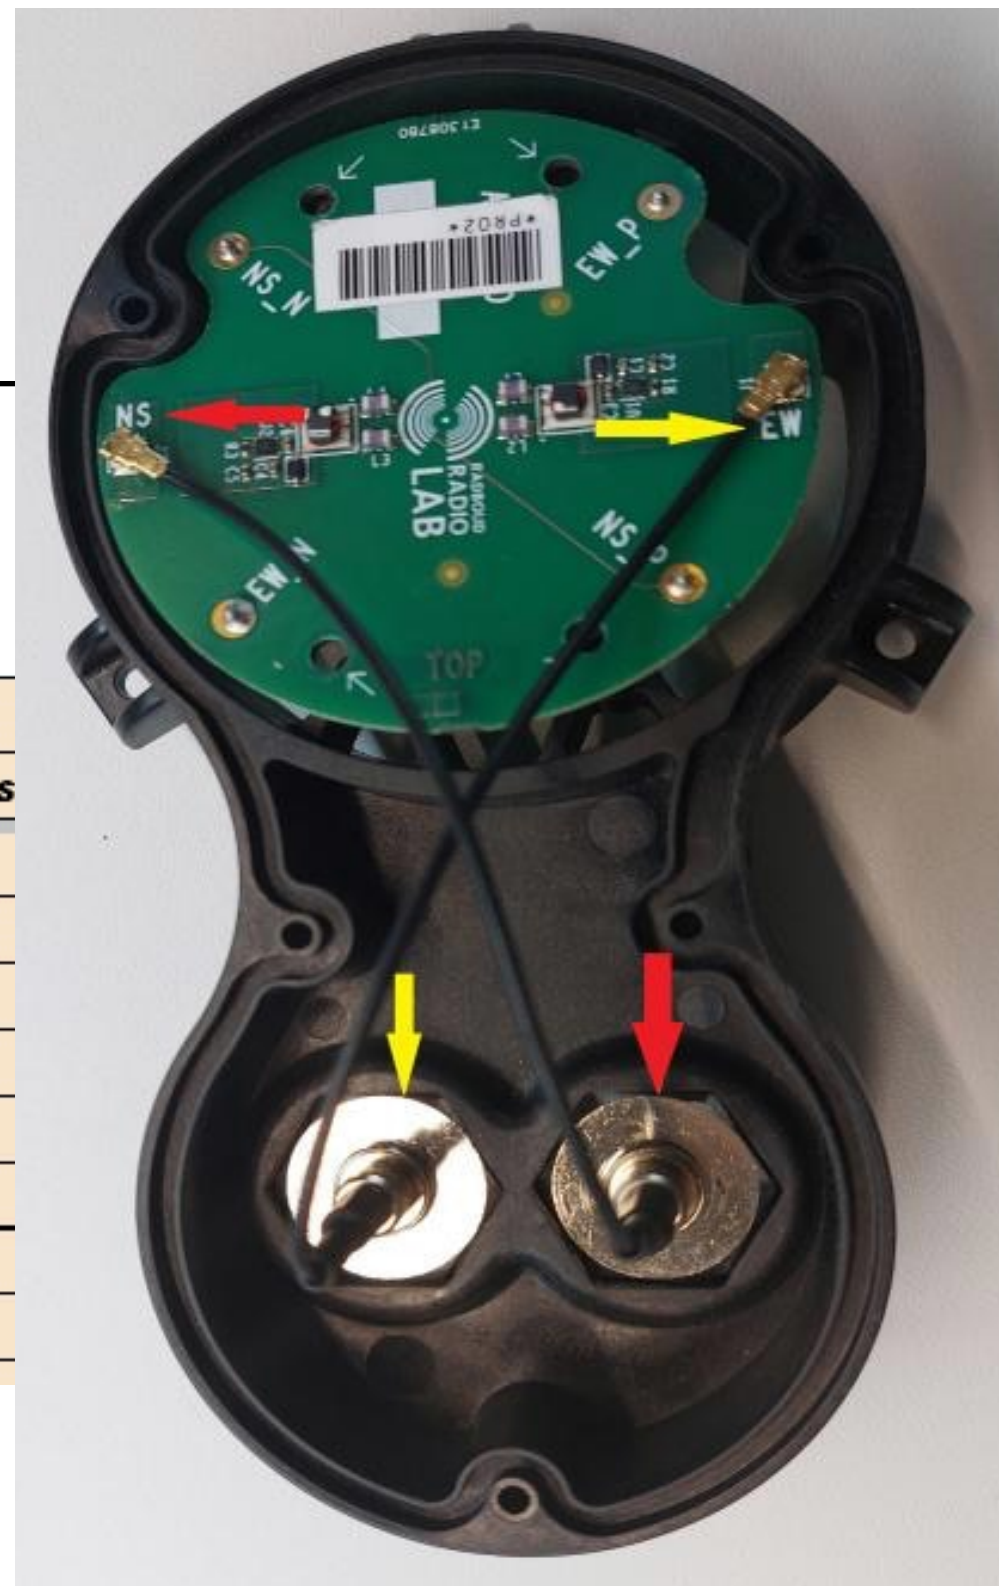
- Main issue from deployment:**

- Any bad connection in signal chain —> bad grounding of LNA —> LNA at risk to induced currents —> LNA amplifier fries
- Causes:
 - Bad contact of self-cutting screw from LNA to SALLA loops
 - Dirt in LNA housing / cable connectors
 - Damaged cables
- Effect:
 - ‘low-gain’ stations when connection was bad —> one-time fix
 - ‘Dead’ stations when an induced current killed the LNA —> one-time fix

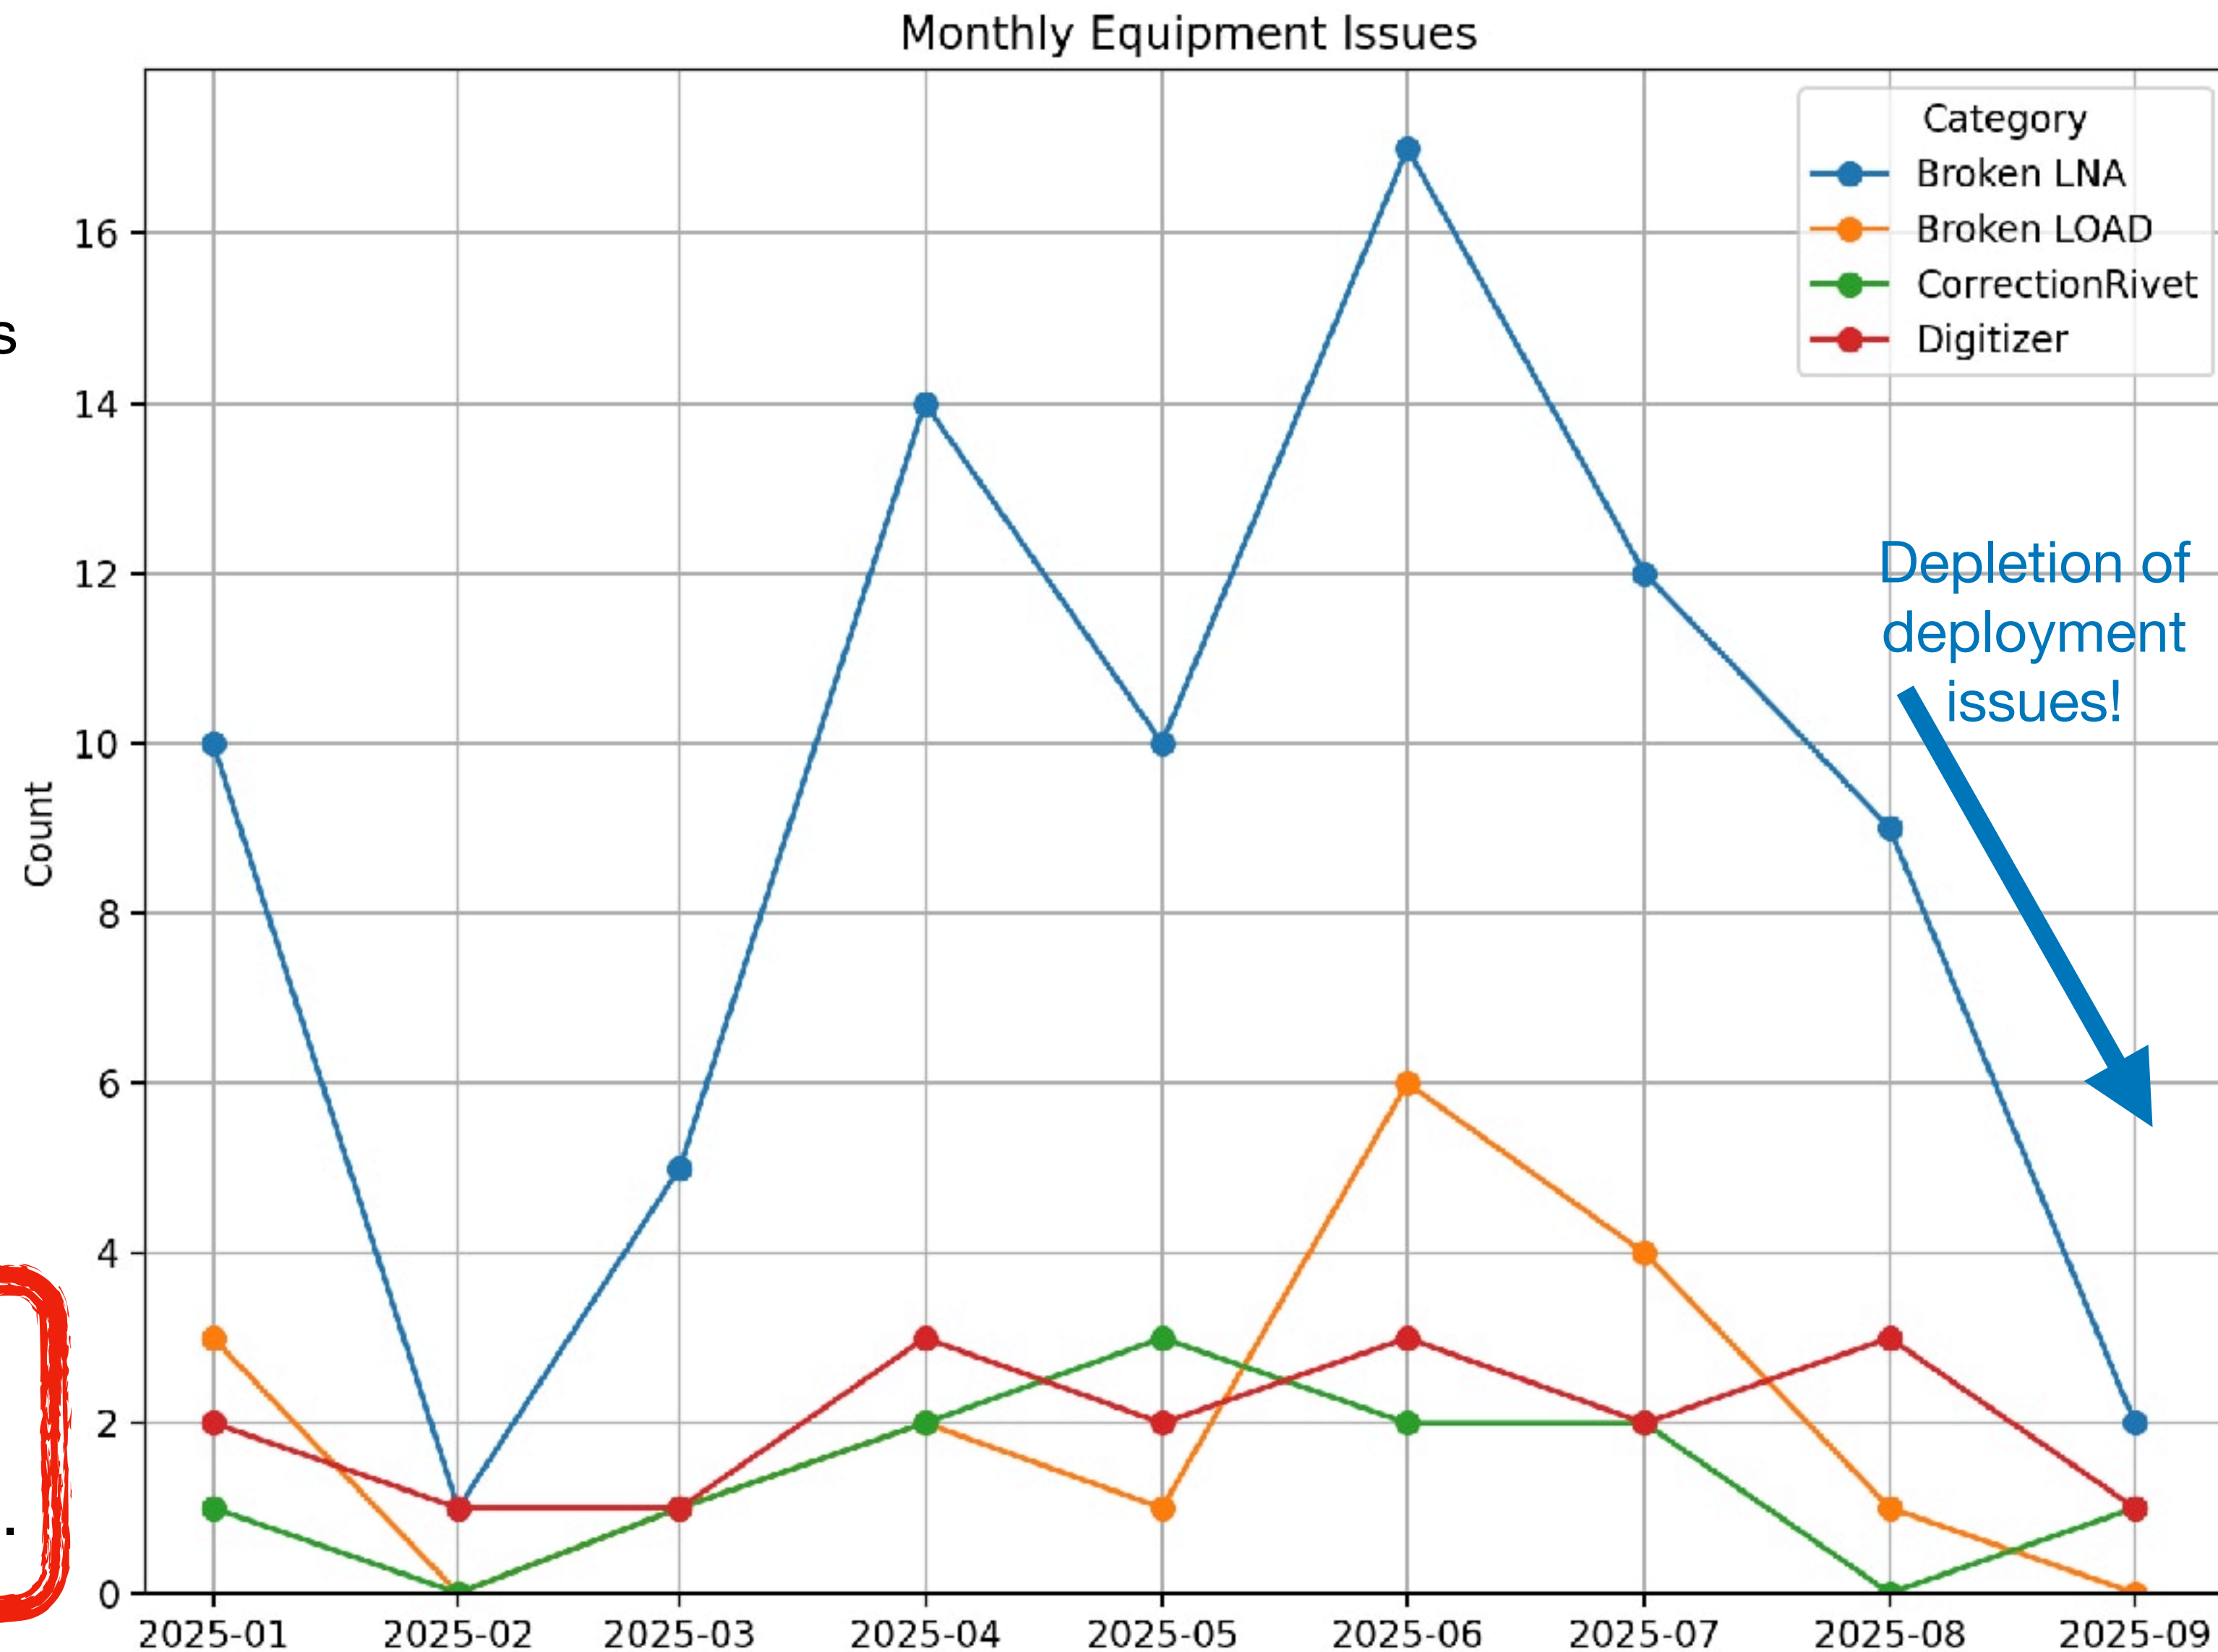
Part 1: Failure modes & maintenance

- ‘Deployment-repairs’ of **LNAs** nearly done (dropping since June) —> going to zero ‘soon’
- **Bottom loads** follow LNA ‘deployment’ issues (also bad connections)
- Steady low failure rate of **Digitizers**: 2/month —> 240 over 10 years (ok with spares. Repairs possible)
- Steady low failure of **rivets**/rotations. Windy regions (e.g. along river) mentioned by Marcos. Wind repairs to SD GPS/solar also not uncommon.

- **So:**
 - Deployment issues are mostly solved
 - ‘non-deployment’ failure rate looks nominal.

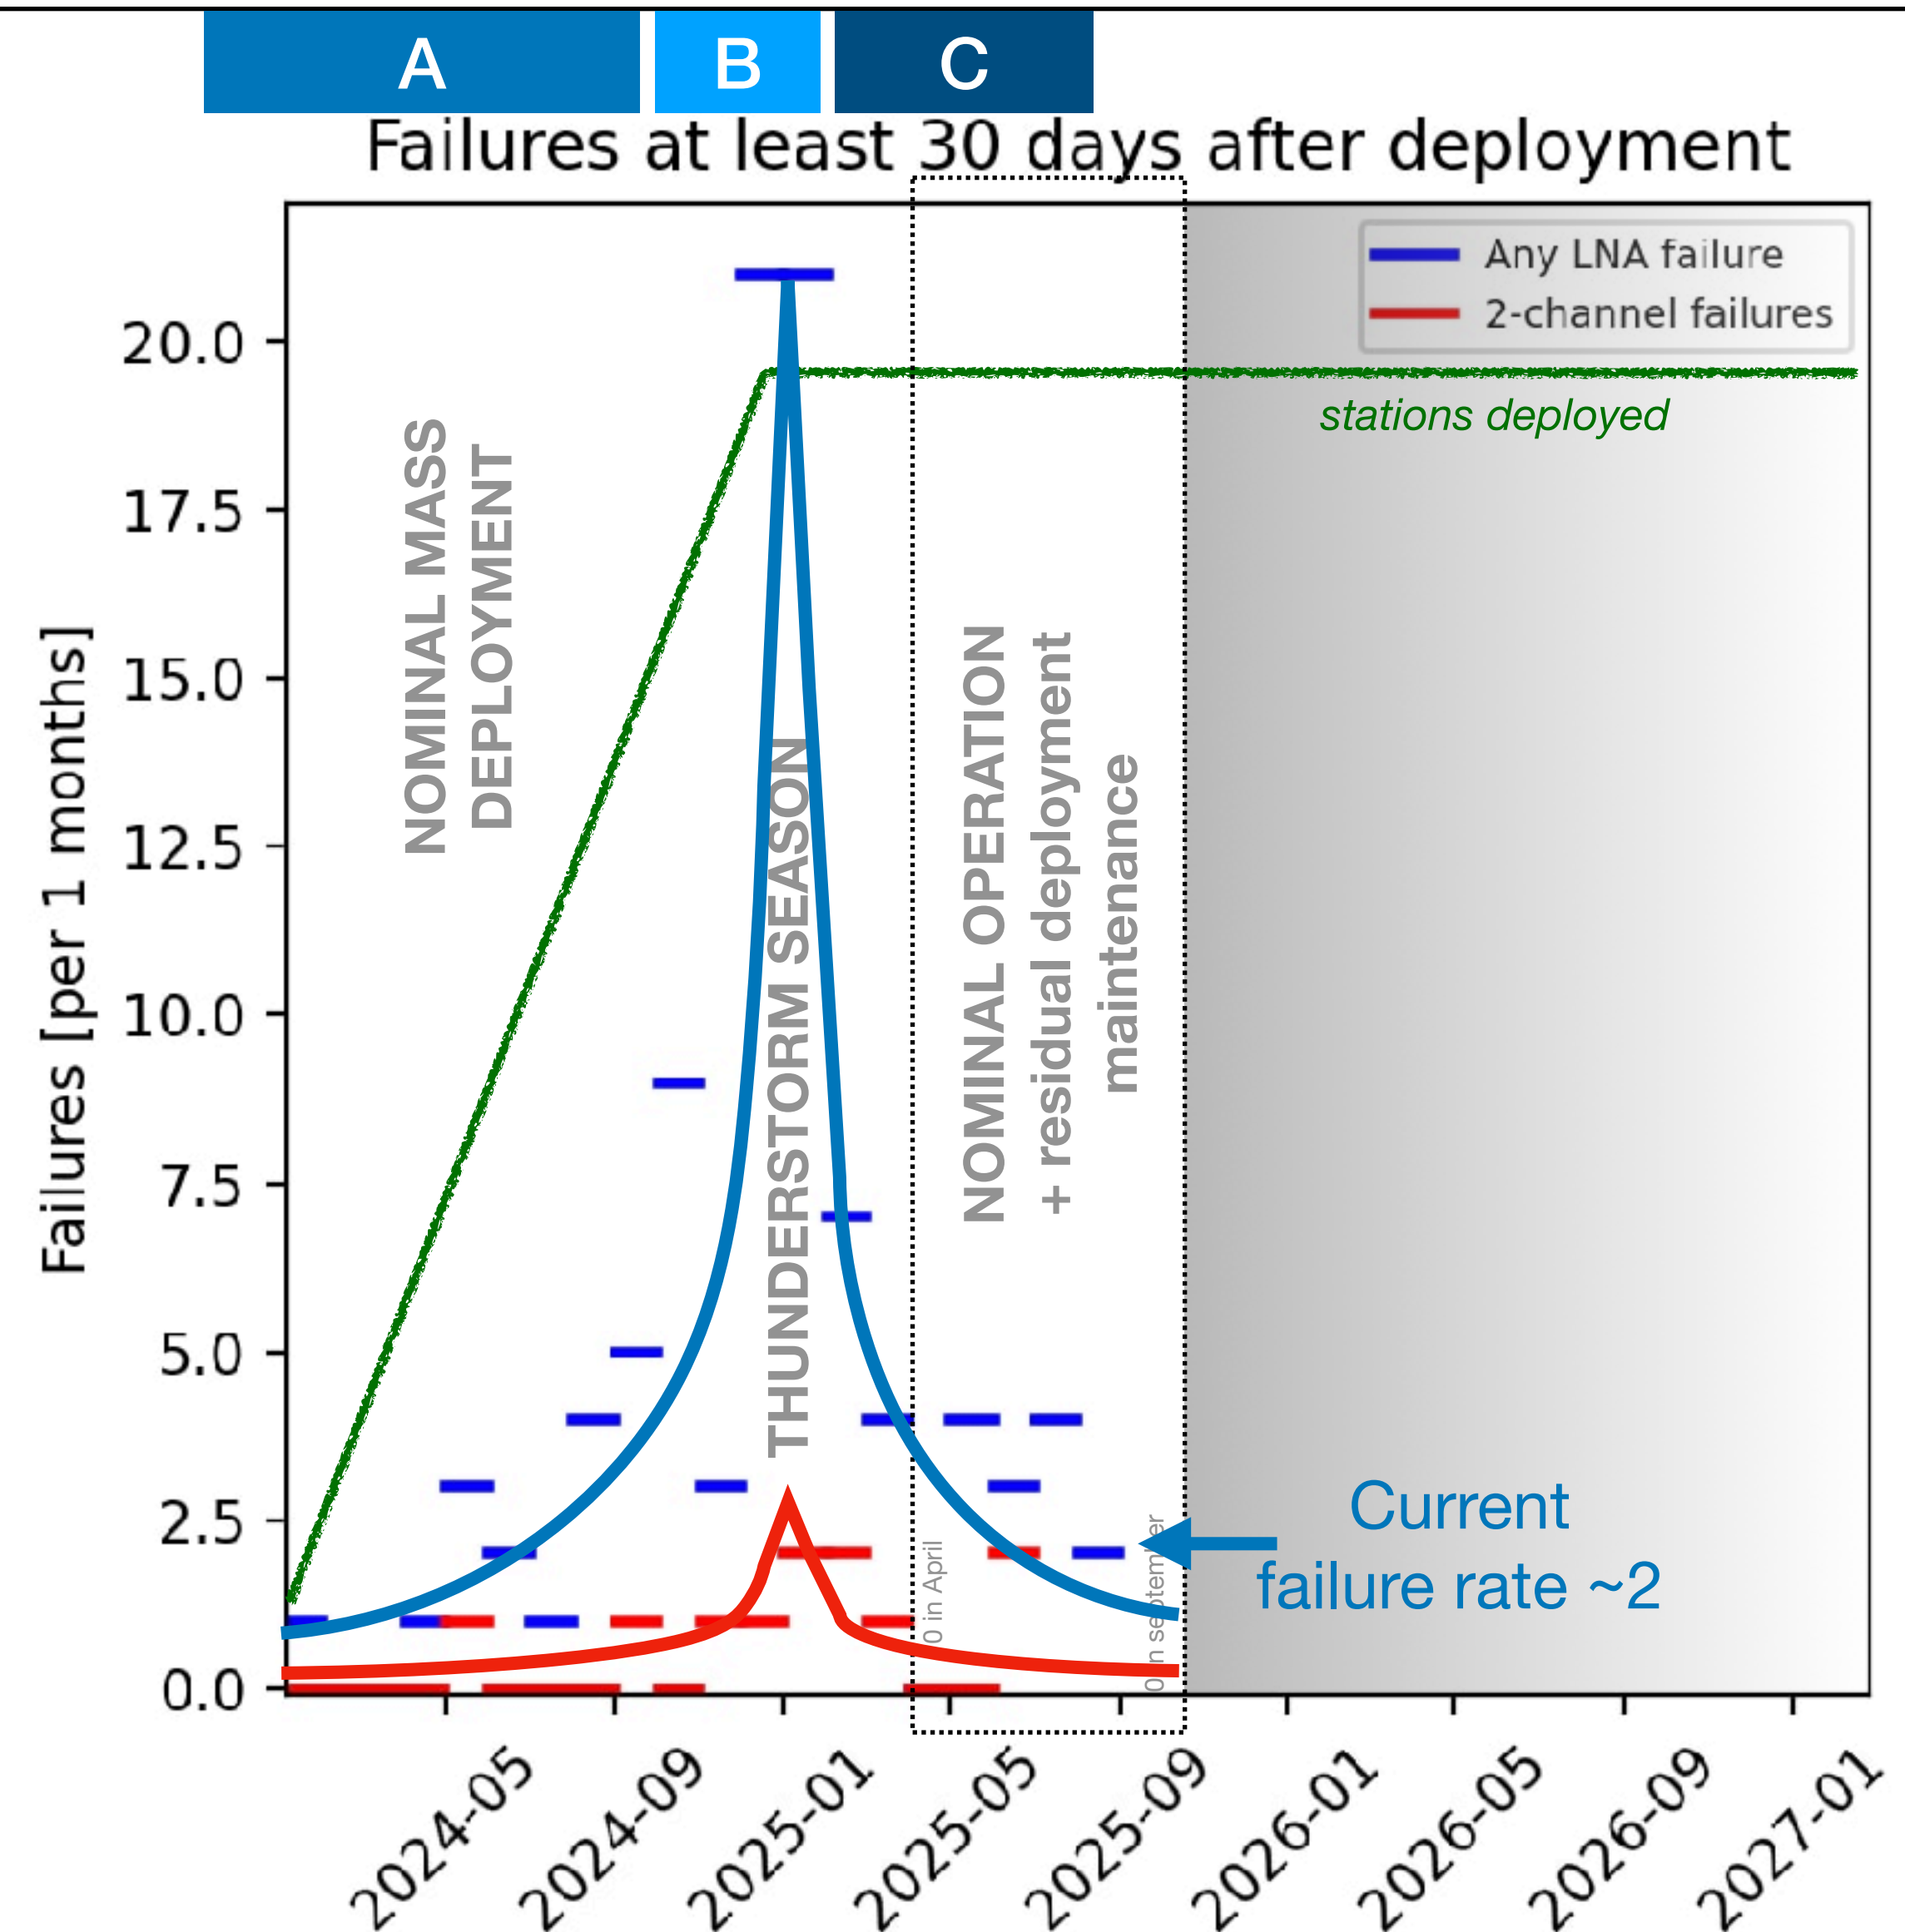
Part 2: Current failure rate from MoRD data

- **A: During deployment:**
—> relatively many issues
- **B: Thunderstorm season** Dec-Jan last year
—> bad connections caused many LNA failures
bad connection
—> *bad grounding*
—> *build up charge*
- **C: April 1 - Oct 1 period:**
New 13 'dead channel' flagged stations
 - 2 firmware issues (false dead flags)
 - 3 at LNA
 - 3 before LNA (crushed cable, issue at bottom load, ...)
 - 5 unknown cause (likely some loose connection in cable/LNA/bottom load)
- So, 1-2 'failures' per month, part not even the LNA itself.
—> 1/month failure rate (excl. thunderstorms)

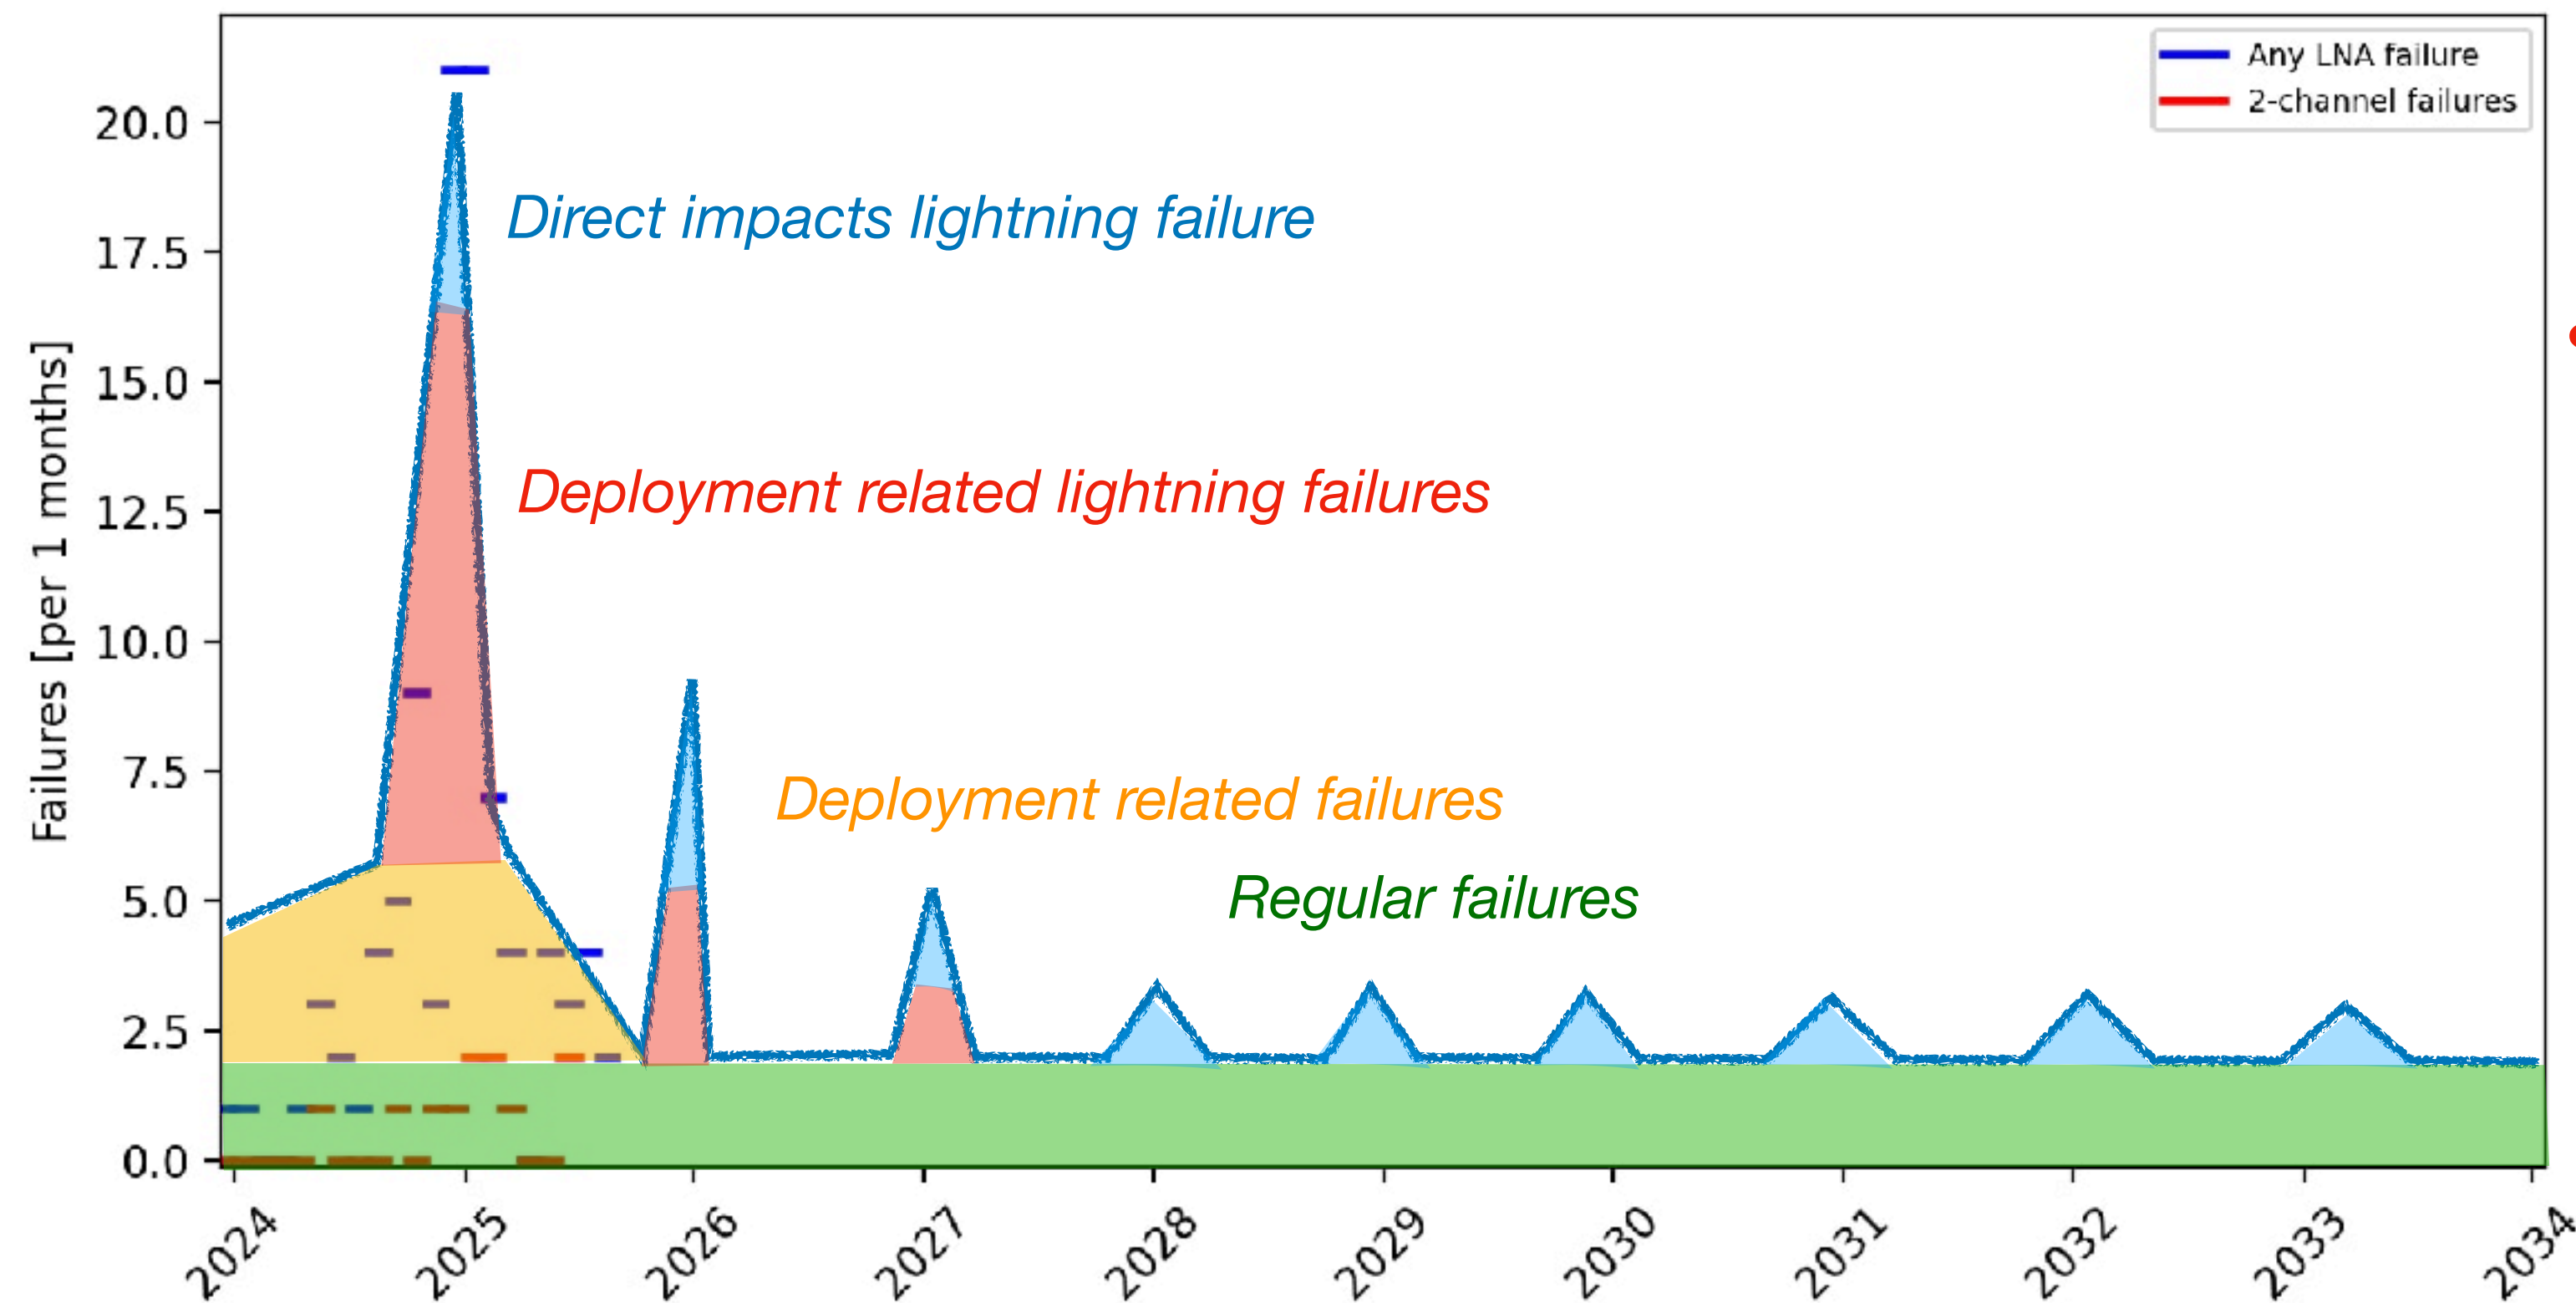
Part 2: Best guess at a 10yr RD LNA forecast

- My expectation:
 - Deployment-related failures will slowly all be fixed. <— Failure rates as reported in Nov'24 and Mar'25 seemed high due to this
 - Deployment-related failures induced by lightning will similarly decrease <— cause of big figure peak in Dec'24
 - Lighting impacts will continue every season <— Possibly similar numbers to SD, but will need to wait for Jan'26 numbers.
 - Regular age-related/random failures will continue. <— Last 6 months indicate this is 1-2/month (They might increase over time?)

after repairing deployment-related issues, we have an extremely low failure rate and a very stable detector operation

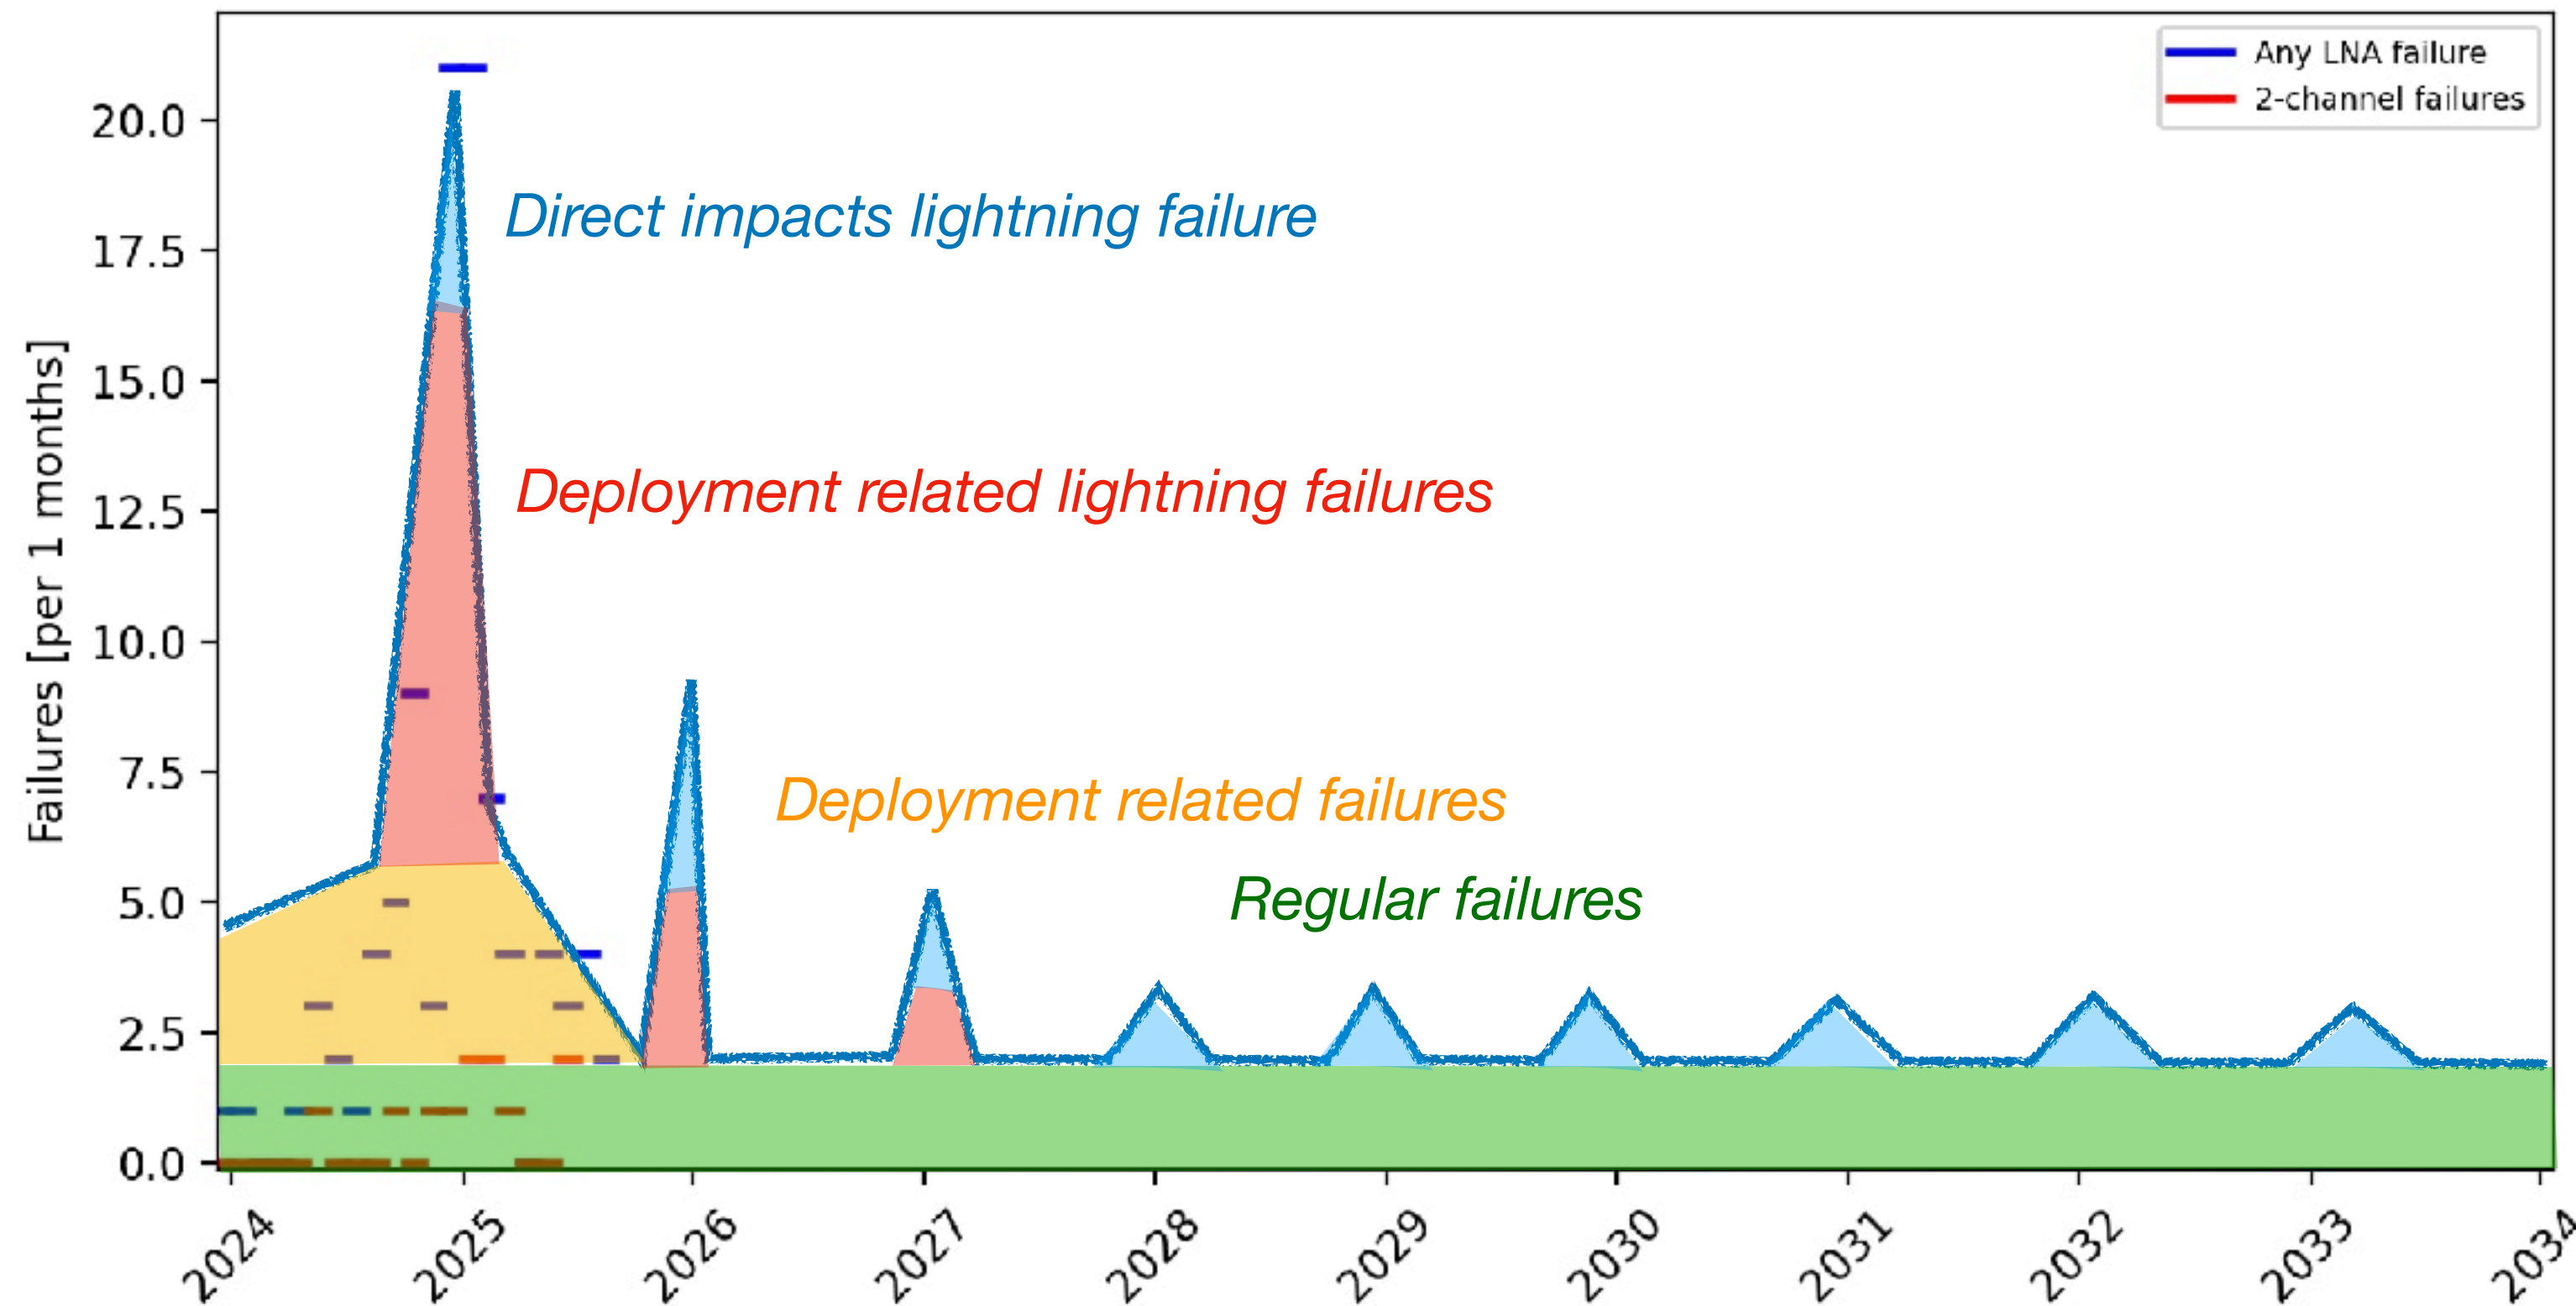
Part 2: Best guess at a 10yr RD LNA forecast

- My expectation:
 - Deployment-related failures will slowly all be fixed. <— Failure rates as reported in Nov'24 and Mar'25 seemed high due to this
 - Deployment-related failures induced by lightning will similarly decrease <— cause of big figure peak in Dec'24
 - Lighting impacts will continue every season <— Possibly similar numbers to SD, but will need to wait for Jan'26 numbers.
 - Regular age-related/random failures will continue. <— Last 6 months indicate this is 1-2/month
(They might increase over time?)

Well within spare budget! (Originally 350 full spares + 3500 spare amplifier chips for repairs) →

Rough conservative estimation of LNA spares needed:

- regular failures: 2/month → 240/decade
- lighting failures: 10/year? → 100/decade?

→ 340 spares? A large fraction likely repairable.
(Optimistically: 120+50 spares??)
(Pessimistically : 240+200 spares???)

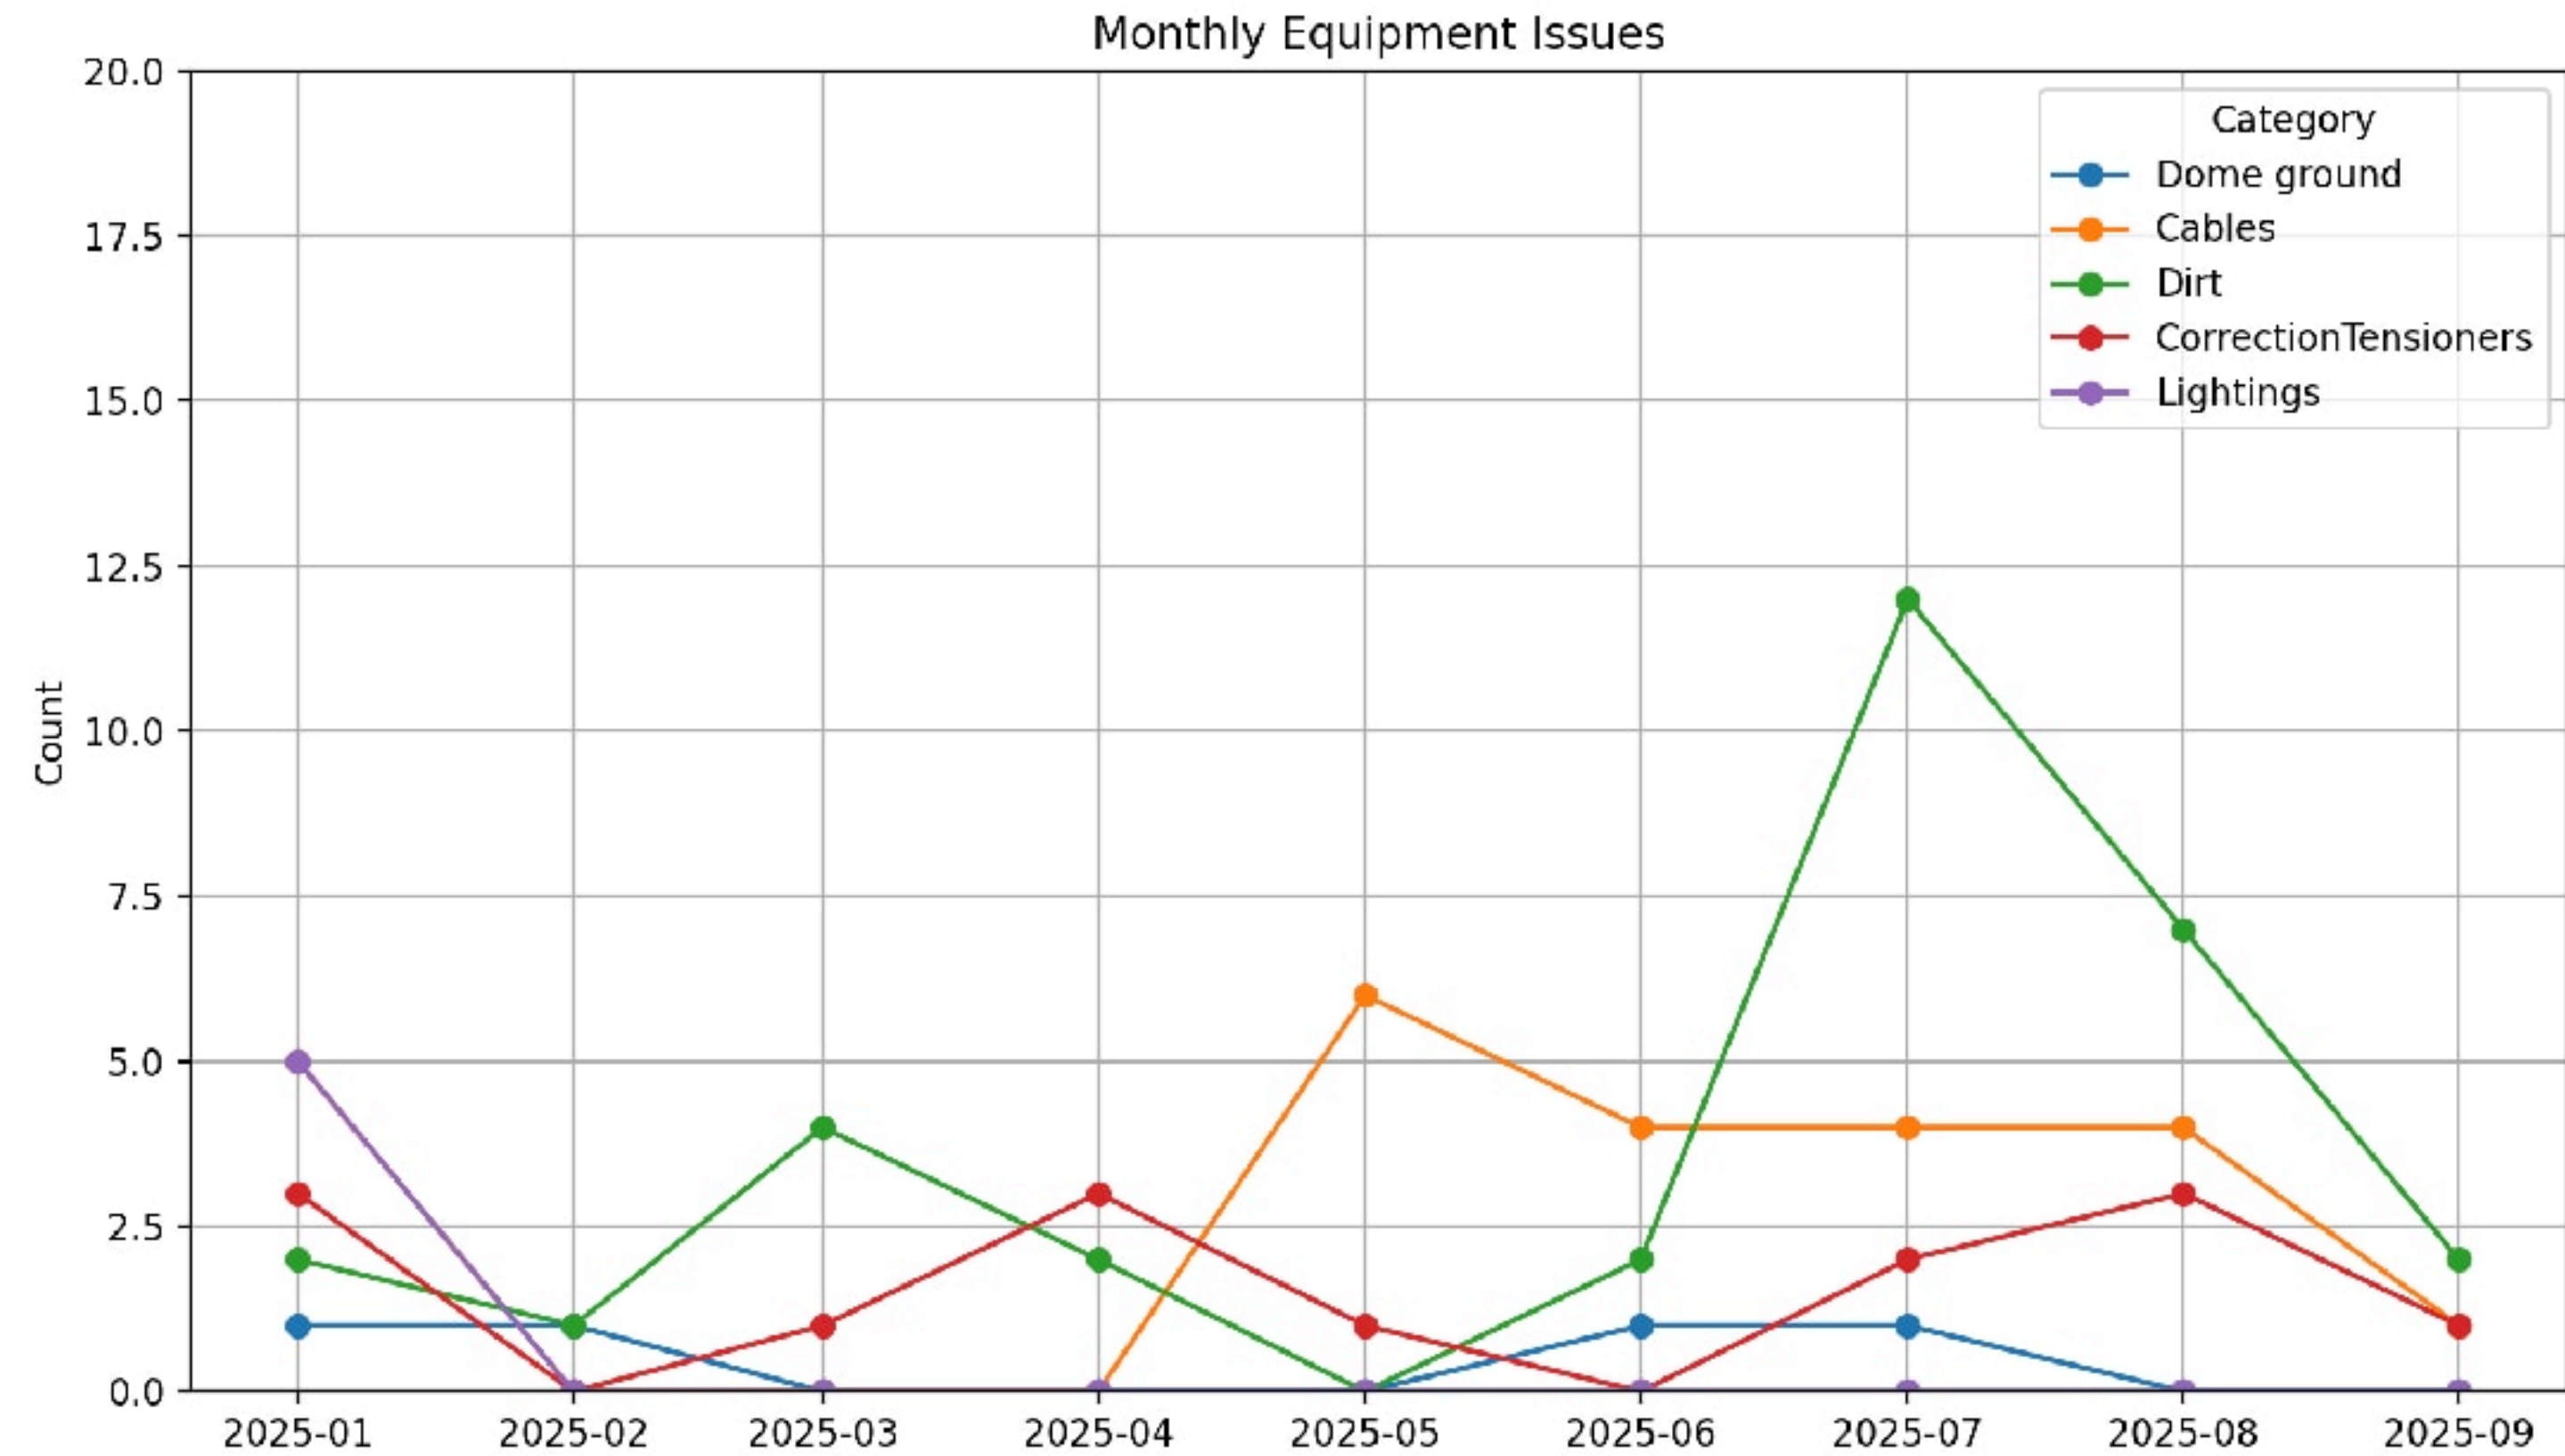
Sub-Failure modes

- Additional sub-categories of issues identified in the field
- Lighting issues did not occur after January (end of thunderstorm season)
- Dirt and Cables refer to the 'bad connection' issues from deployment
- Tensioners refer to broken/stolen tensioner cables from the RD frame to the SALLA.
