Radio Detector

Operations Readiness Report

AugerPrime Radio detector operation readiness review

RD LNA failure analysis

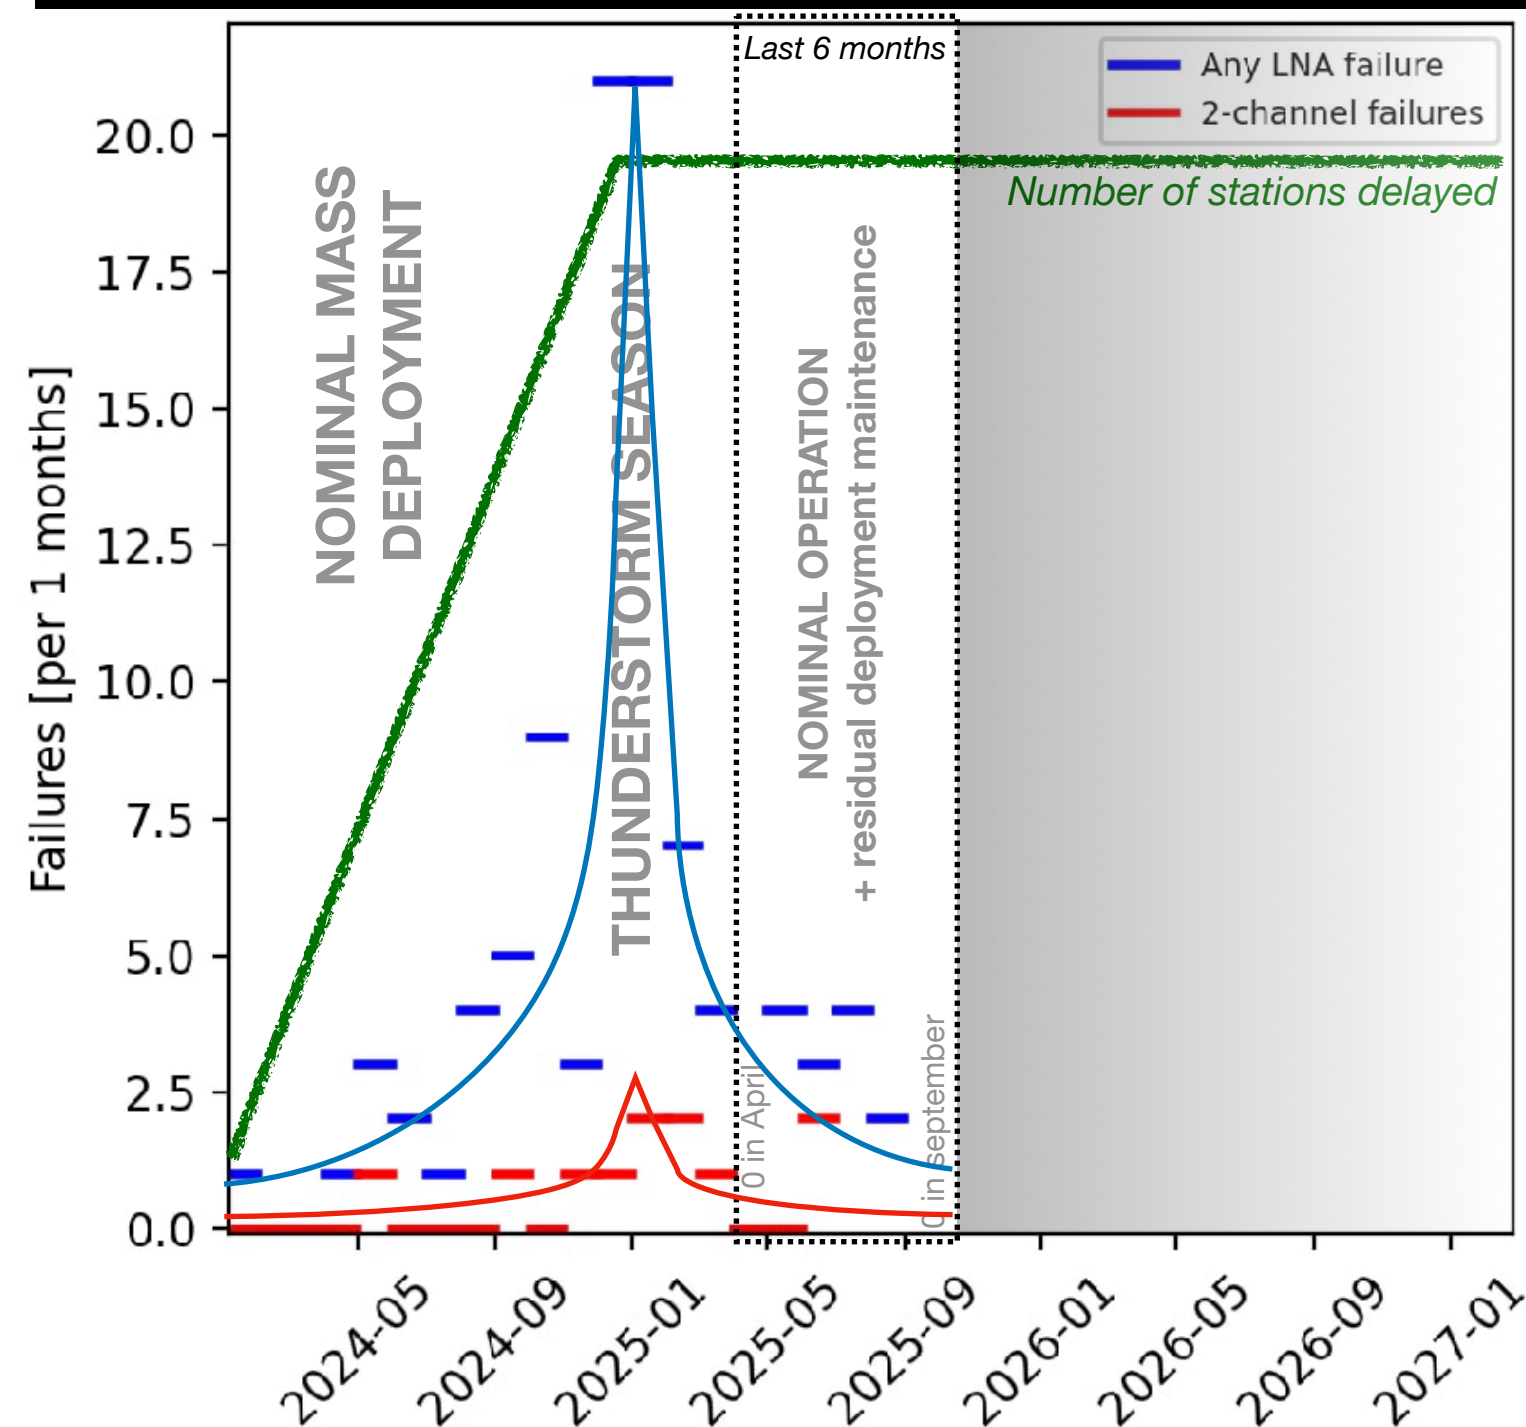
Absolute number of failures per month

- **Failure rate** recent 6 months of 2025 (Apr 1 - Oct 1): **13**. (2 of which are firmware issues, misidentified as bad gain)
 - Average rate: ~2 No-Gain LNAs / month (some are very short term, so likely due to bad connections rather than failures. See next page)

- **Conclusion: the rate of LNA failures has been 1-2 per month in the past 6 months. —> 10-20 per year —> 100-200 over 10yr operation (excl direct lightning hits, excl residual deployment issues)**

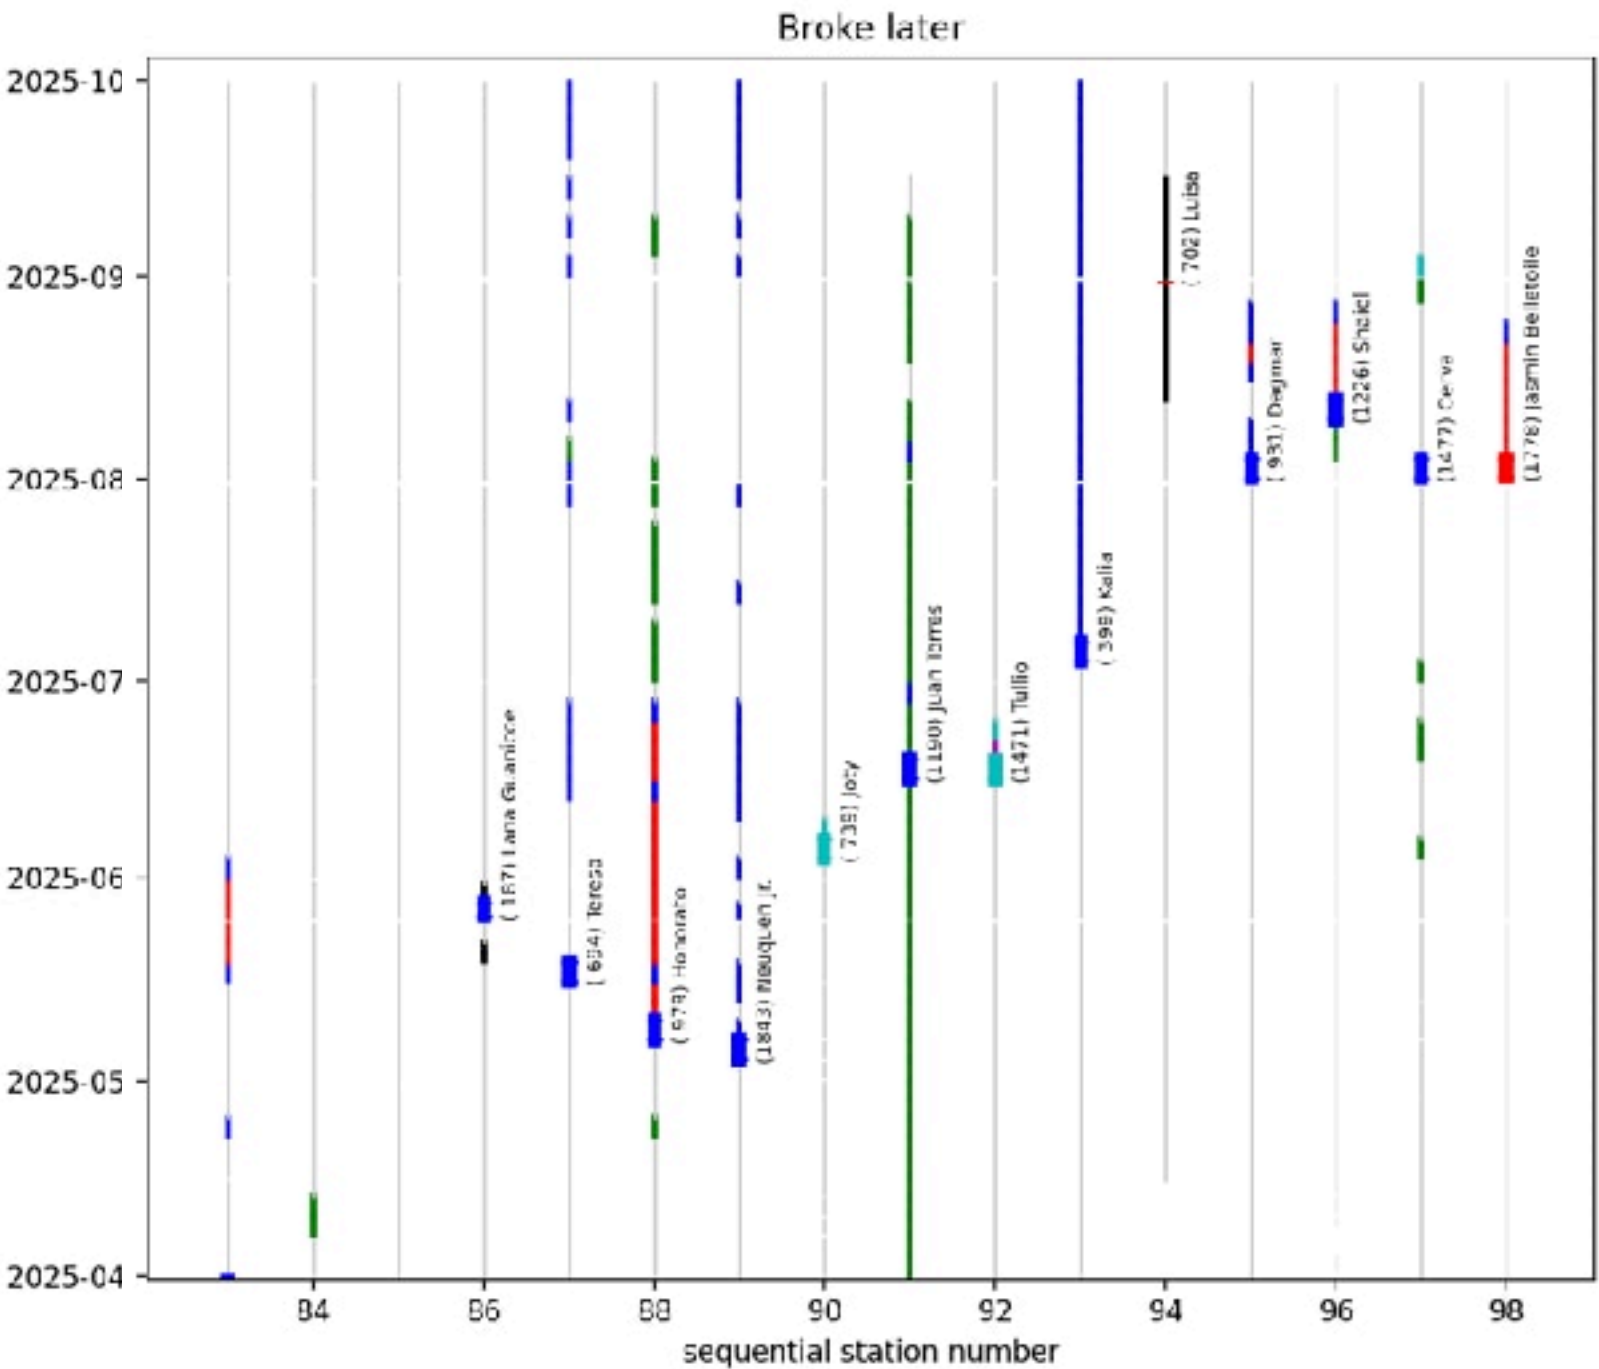
Detailed analysis of failures Apr-Sept

- 13 new stations flagged during 6 month period (apr 1 - Oct 1)
 - 2 with firmware issue (not gain issues)
- 11 with gain flag.**
 - 3 failures at LNA position (2 likely just failures, 1 unstable so likely just bad connections)
 - 3 gain issue before LNA (Dome/mast/base/...) (in the past: crushed cable, sabotage, issue at bottom load, ...)
 - 5 gain issue with unknown cause (likely some loose connection in cable/LNA/bottom load)
- Non-deployment issues likely will expect to continue for next 10 years. These include:
 - Full LNA failures
 - Issues at dome/mast/base
 - > ~6 in 6 months—> Rate of 1/month
- Lightning season might cause more failures:
 - With some residual deployment bad connectiities: increased failures like in Dec 2024
 - In the future when deployment issues get resolved: likely just similar failures to SD

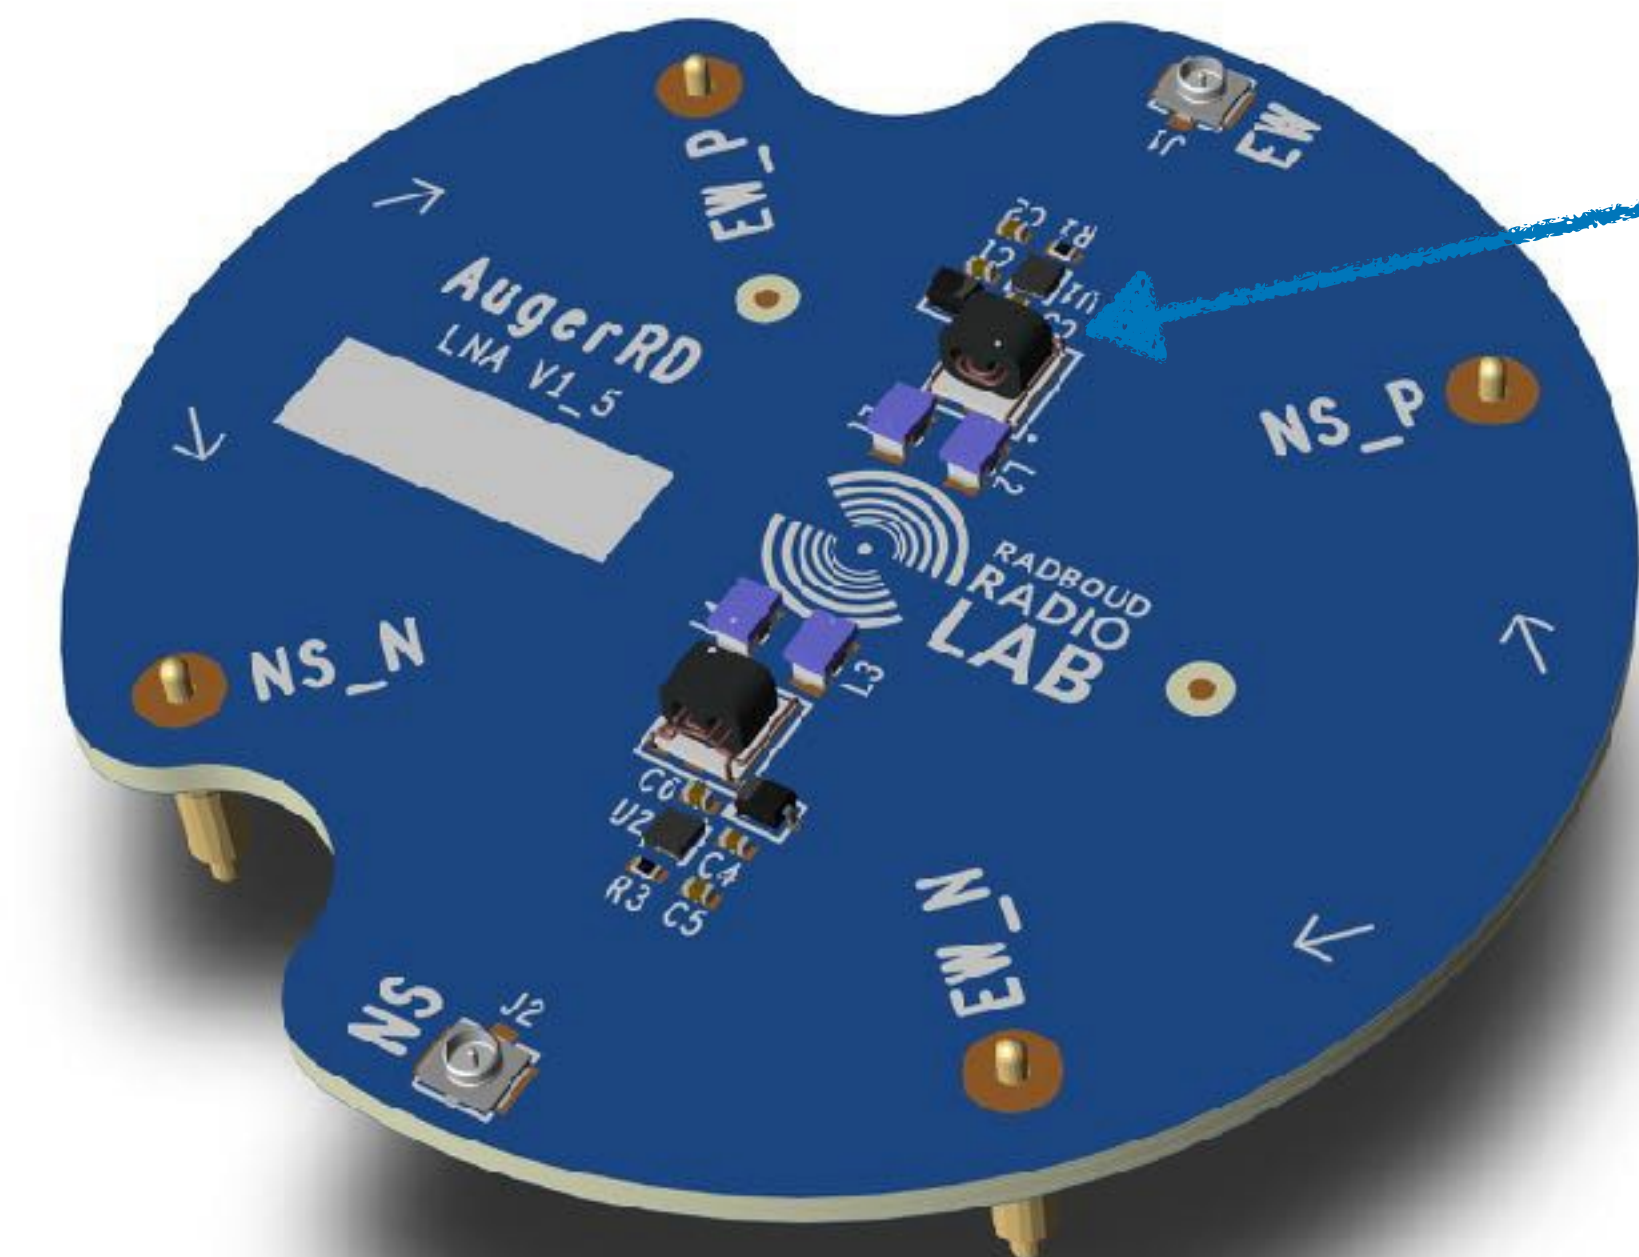
GRF4002

- some of the amplifier chips break (due to over voltage)
- successfully repaired by Mauro
- bought 1000 + 2500 additional chips
