AugerPrime
Scintillator Surface Detector
OPERATIONS READINESS REVIEW
The Detector

AugerPrime
Scintillator Surface Detector
OPERATIONS READINESS REVIEW
The Status

AugerPrime
Scintillator Surface Detector
OPERATIONS READINESS REVIEW
Maintenance and Spares

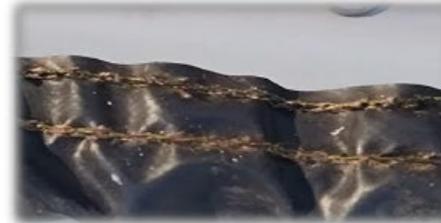
Cable protection problem:

Cable protective jackets

Sewing thread is not UV resistant, so it breaks

A temporary solution: use UV-resistant zip ties to keep the jackets closed

Possible alternatives identified, but not available in Argentina – work in progress

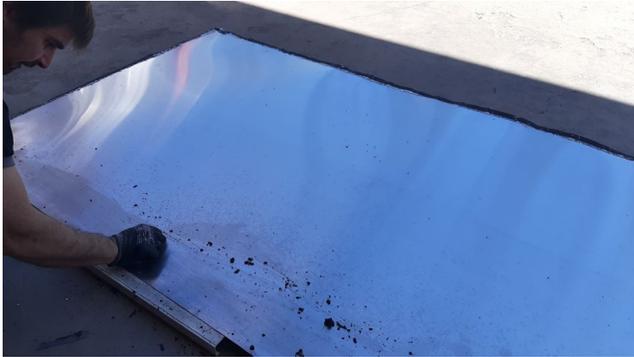
sealing

Case 2 and 3 Cookie problem: cookie misplaced.

Cleaning and Flattening the top cover (long and tedious work)

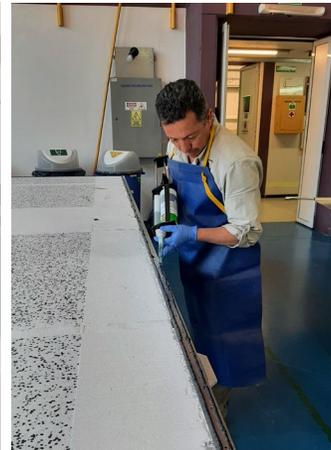
Cleaning and Flattening the upper panel (long and tedious work)

sealing

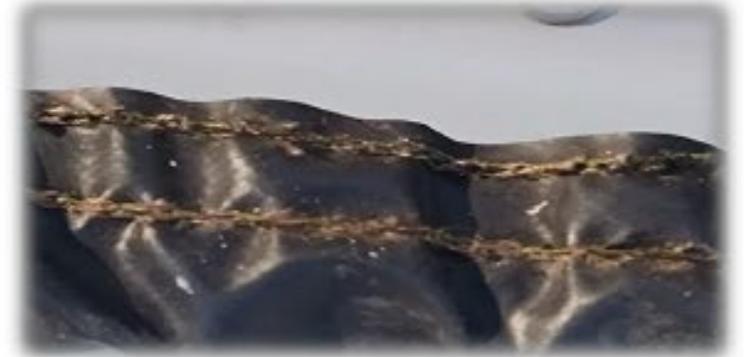
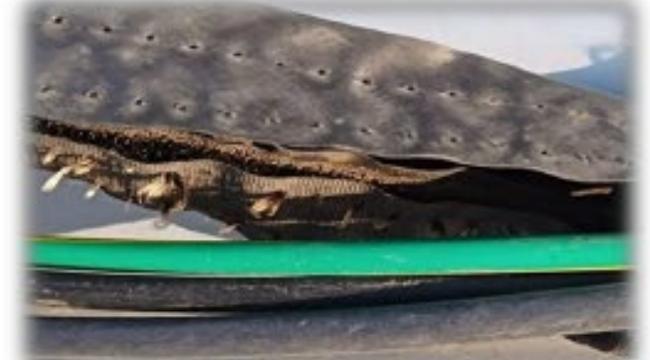
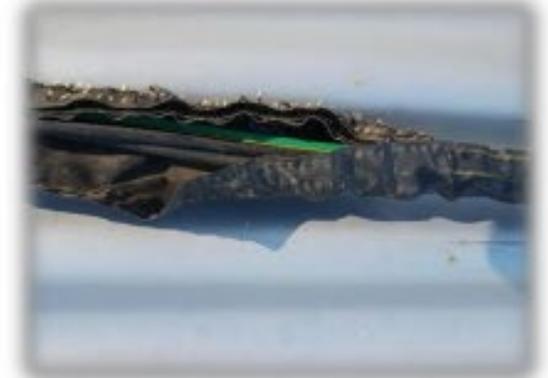
Riguarda i cavi che collegano il PMT di SSD al «DOME» (dove si trova la UUB)

1- Estendere il copricavo che dall'antenna RADIO scende verso il cavo SSD PMT. I due cavi tecnicamente dovrebbero poi viaggiare nello stesso copricavo. (il copricavo RD non ha un diametro che possa contenere entrambi)

2- Sostituire il copricavo SSD-PMT - Dome
